Island Environmental Health & Safety Pre-Demolition Hazardous Materials Investigation 177 Third Street, Duncan, BC

**Pre-Demolition
Hazardous Materials Investigation**

177 Third Street, Duncan, BC

July 2023

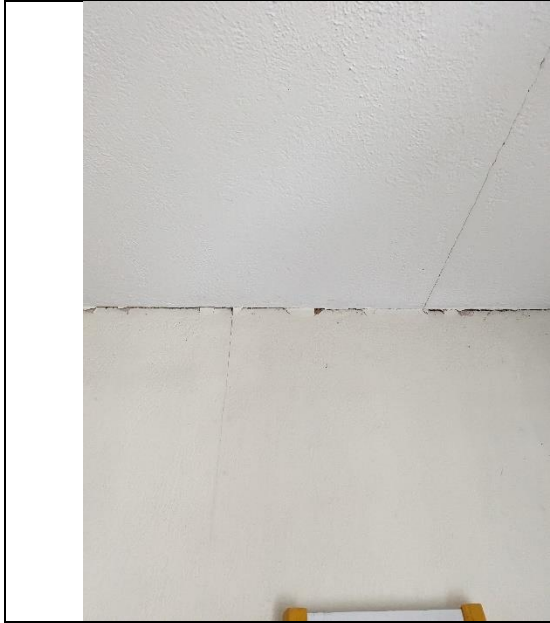
Sample: 50288 – 1
Location: Living Room – Ceiling
Description: Drywall Joint
Compound/Textured Coating
Asbestos: **Chrysotile 1%**

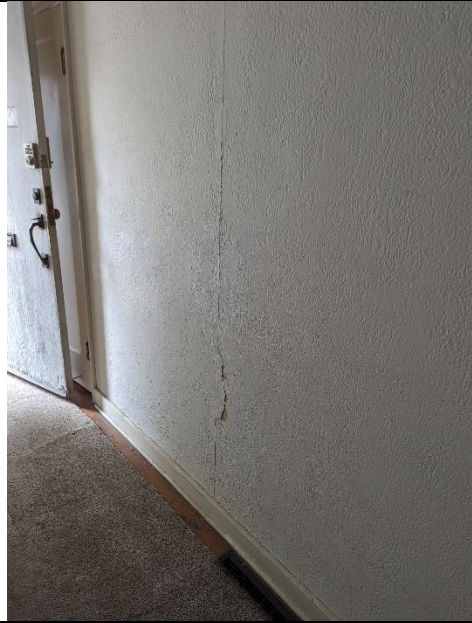
Sample: 50288 – 2
Location: Living Room – Wall
Description: Drywall Joint
Compound/Textured Coating
Asbestos: **Chrysotile 1%**

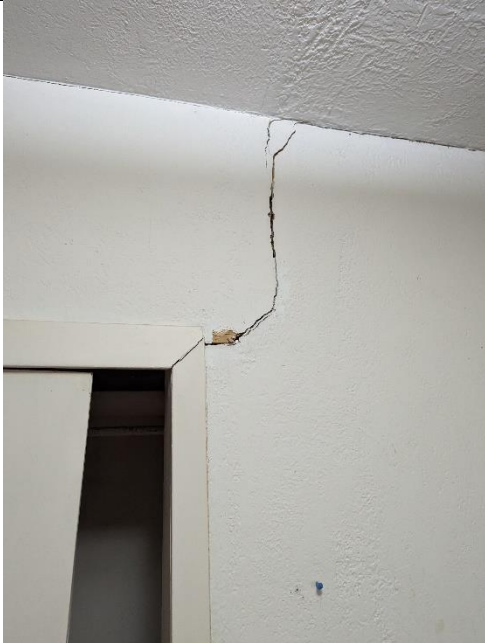
Sample: 50288 – 3
Location: Bedroom 1 – Wall
Description: Drywall Joint
Compound/Textured Coating
Asbestos: **Chrysotile 1%**

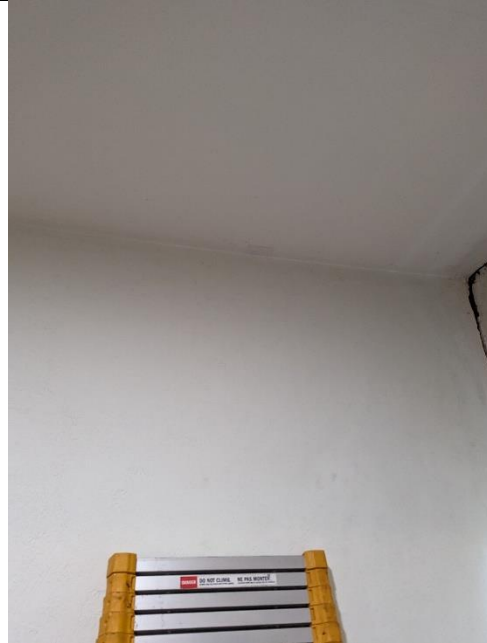
Sample: 50288 – 4
Location: Dining Room – Ceiling
Description: Drywall Joint
Compound/Textured Coating
Asbestos: **Chrysotile 1%**

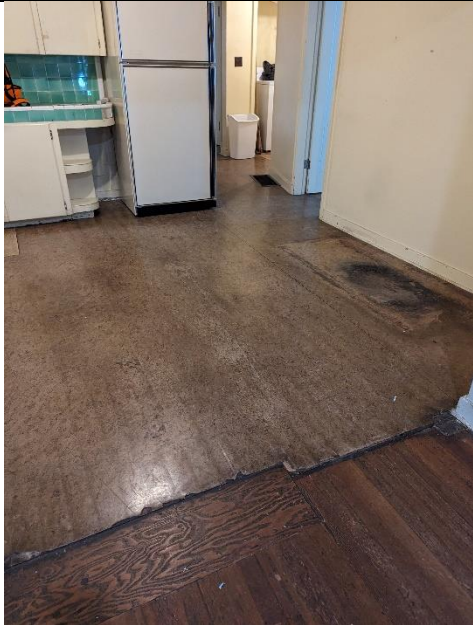
Sample: 50288 – 5
Location: Kitchen
Description: Sheet Vinyl Flooring (Dark Brown)
Asbestos: None detected

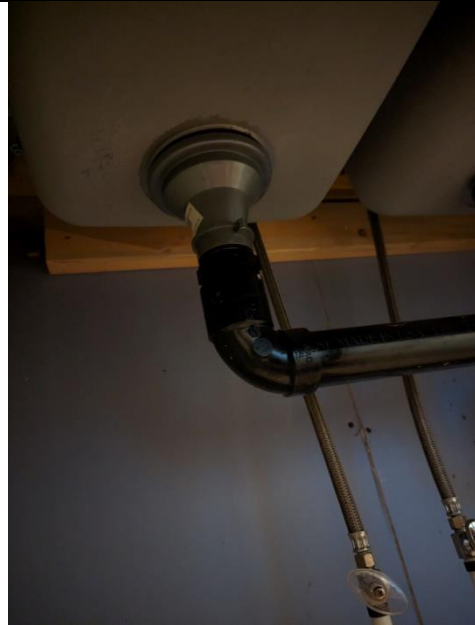
Sample: 50288 – 6
Location: Kitchen – Sink
Description: Mastic (Grey)
Asbestos: None detected

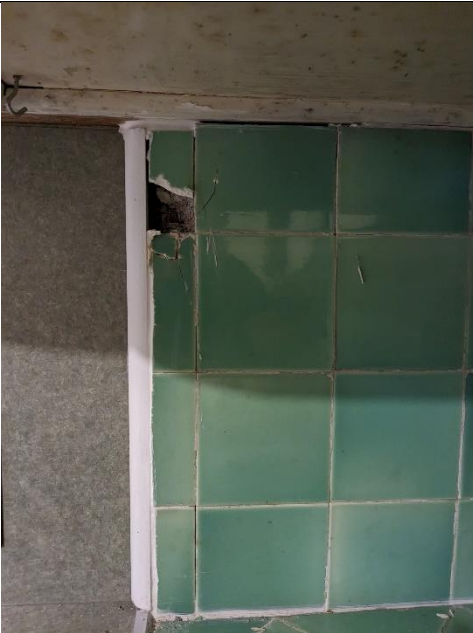
Sample: 50288 – 7
Location: Kitchen – Backsplash
Description: Concrete / Grout / Caulking / Adhesive
Asbestos: None detected

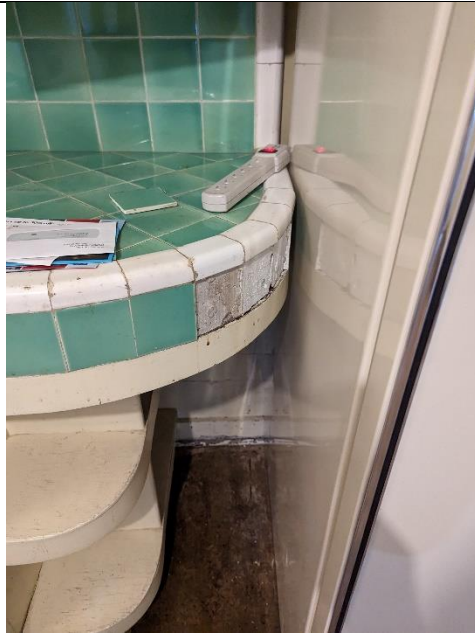
Sample: 50288 – 8
Location: Kitchen – Backsplash
Description: Grout
Asbestos: None detected

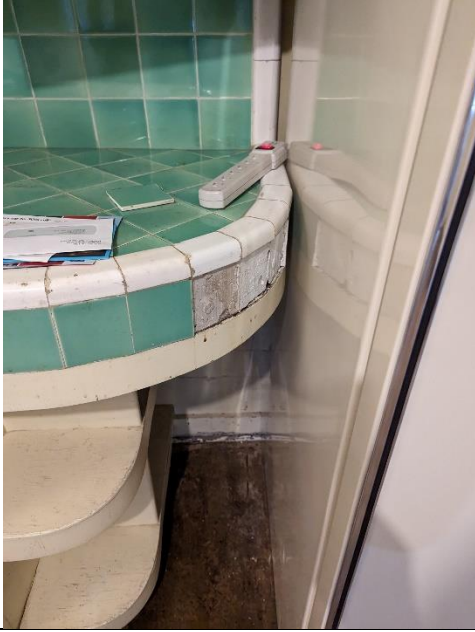
Sample: 50288 – 9
Location: Kitchen – Backsplash
Description: Grout
Asbestos: None detected

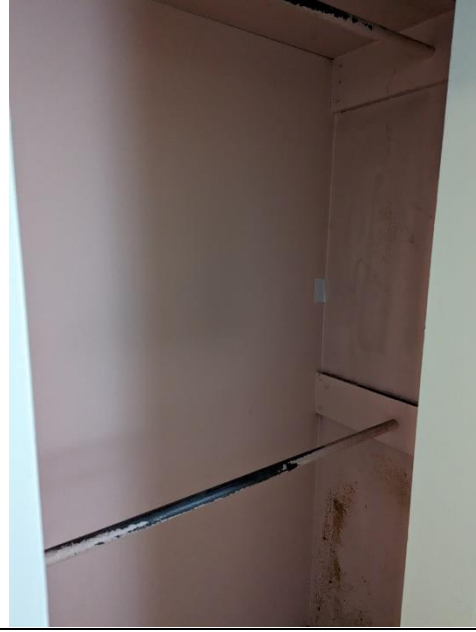
Sample: 50288 – 10
Location: Bedroom 2 – Closet Wall
Description: Drywall Joint Compound
Asbestos: None detected

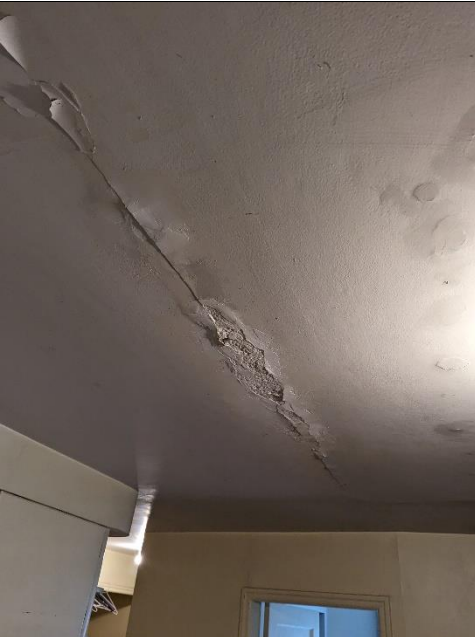
Sample: 50288 – 11
Location: Kitchen – Ceiling
Description: Patching Compound
Asbestos: None detected

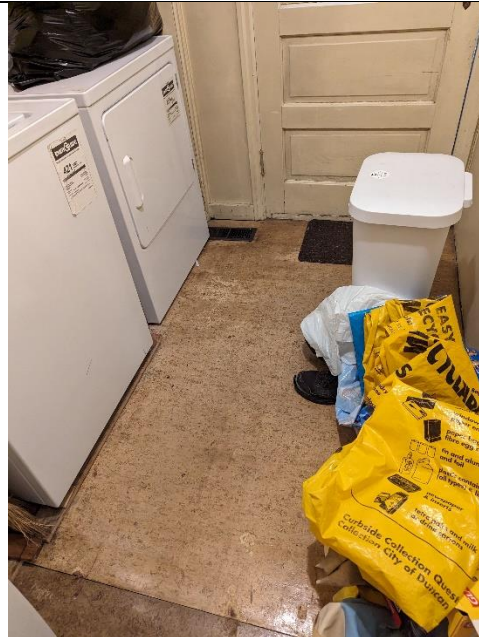
Sample: 50288 – 12
Location: Laundry
Description: Sheet Vinyl Flooring (Light Brown)
Asbestos: None detected

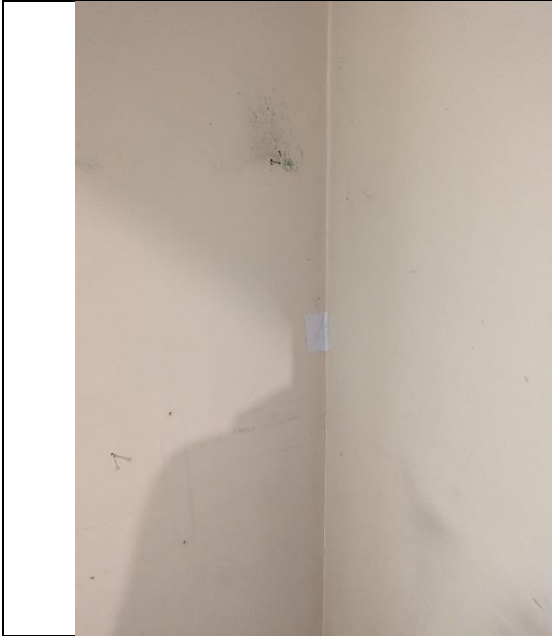
Sample: 50288 – 13
Location: Hallway
Description: Drywall Joint Compound
Asbestos: **Chrysotile 1%**

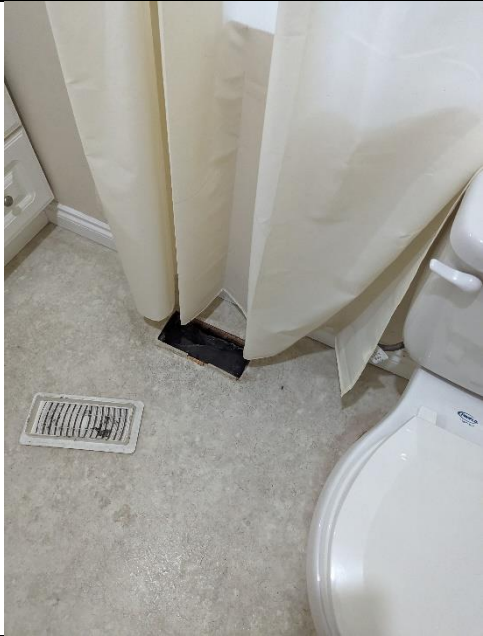
Sample: 50288 – 14
Location: Bathroom 1
Description: Sheet Vinyl Flooring (Grey)
Asbestos: None detected

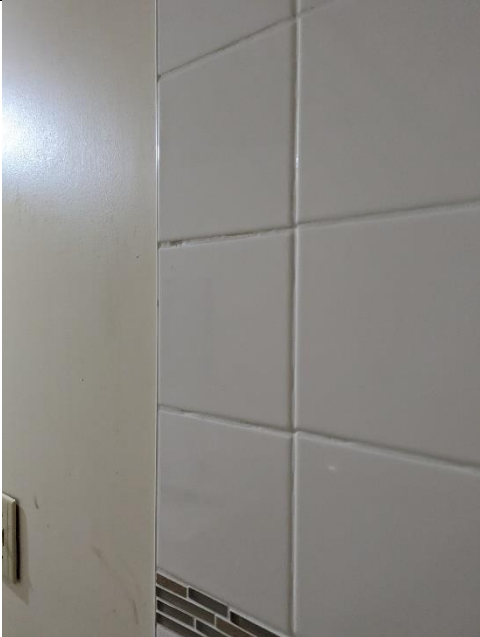
Sample: 50288 – 15
Location: Bathroom 1 – Tub Surround
Description: Grout
Asbestos: None detected

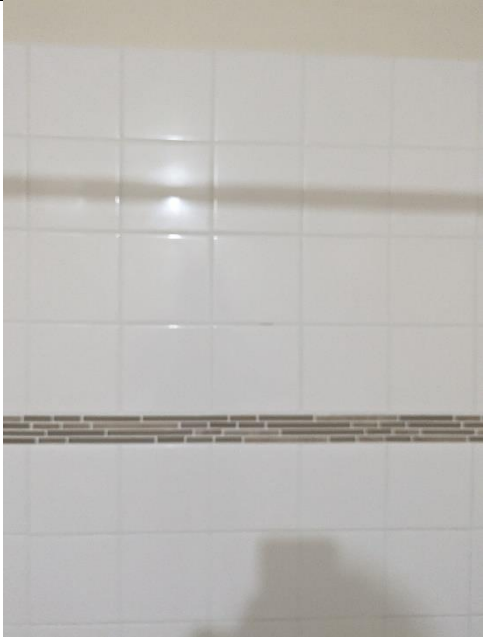
Sample: 50288 – 16
Location: Bathroom 1 – Tub Surround
Description: Grout
Asbestos: None detected

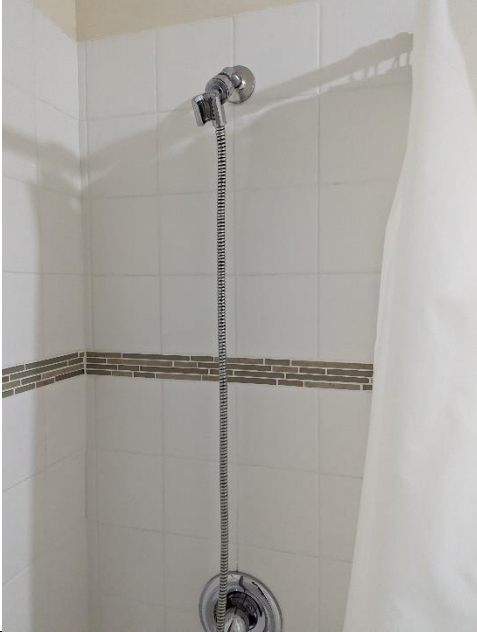
Sample: 50288 – 17
Location: Bathroom 1 – Tub Surround
Description: Grout
Asbestos: None detected

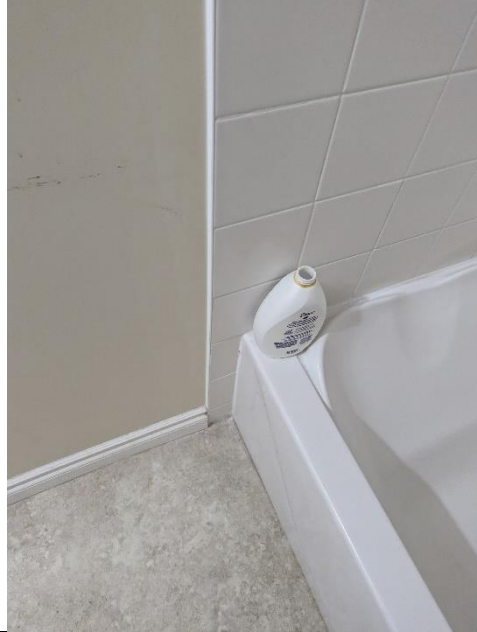
Sample: 50288 – 18
Location: Bathroom 1 – Tub Surround
Description: Caulking
Asbestos: None detected

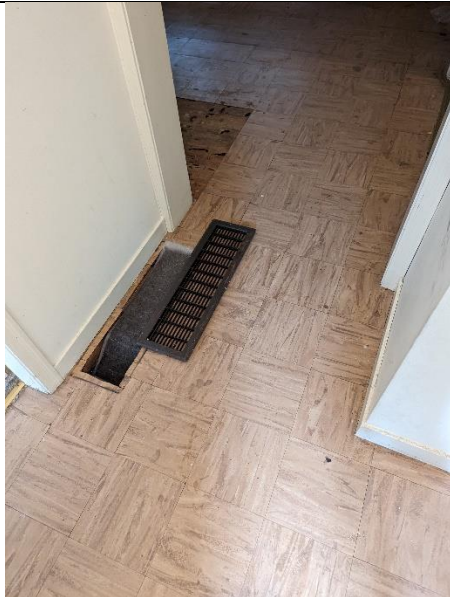
Sample: 50288 – 19
Location: Hallway
Description: 9" x 9" Vinyl Floor Tile (Brown)
Asbestos: None detected

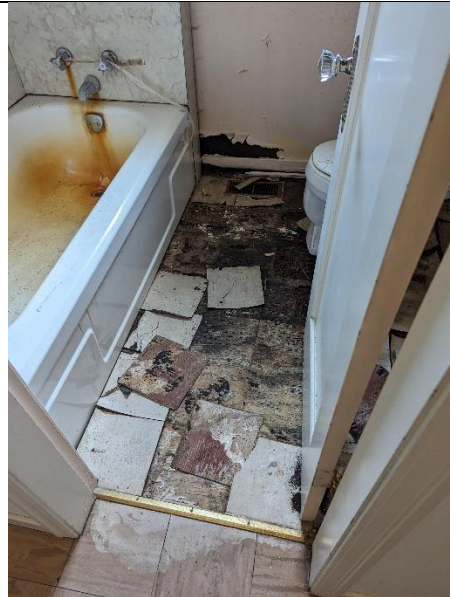
Sample: 50288 – 20
Location: Bathroom 2
Description: 9" x 9" Vinyl Floor Tile (Grey)
Asbestos: None detected

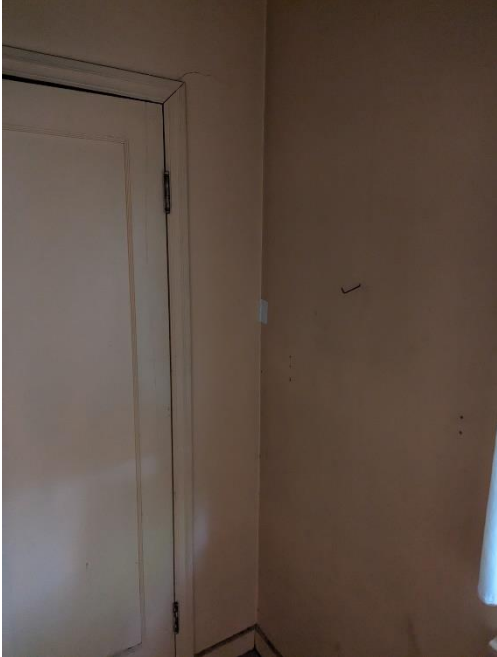
Sample: 50288 – 21
Location: Kitchen 2 – Wall
Description: Drywall Joint Compound
Asbestos: None detected

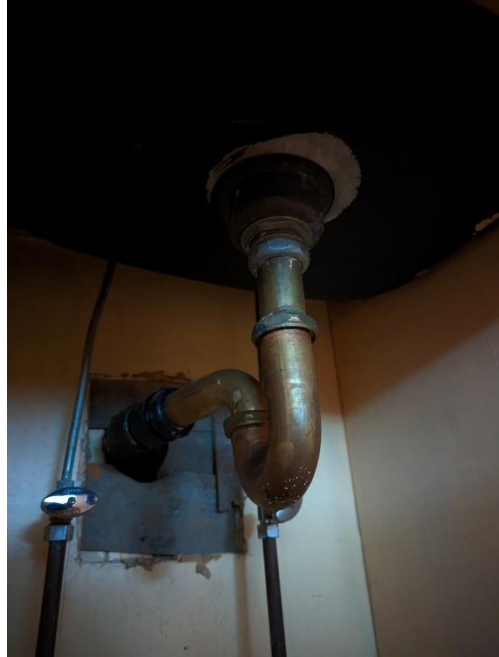
Location	Description	Asbestos Type & Percentage	Approximate Quantity	Removal Requirements
Kitchen 2 – Sink	Sink Mastic	4% Chrysotile	One (1) sink with associated mastic observed	Moderate risk work procedures
House – Heating System – Throughout	Fibreboard & Duct Tape	Typically, 60% Chrysotile	All heating system components throughout the building	Moderate risk work procedures

Sample: 50288 – 22
Location: Kitchen 2 – Sink
Description: Mastic (Black)
Asbestos: **Chrysotile 4%**

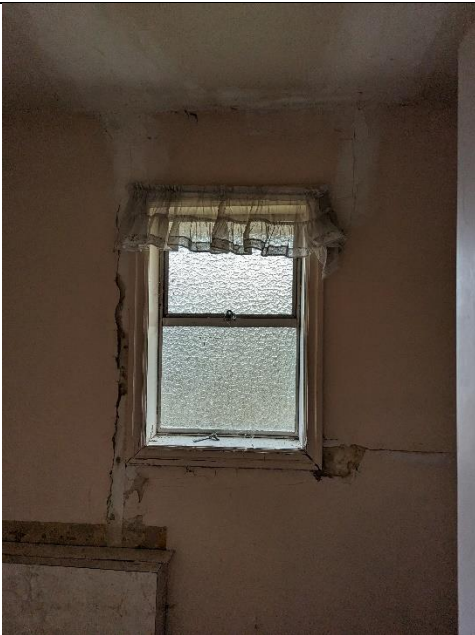
Sample: 50288 – 23
Location: Bathroom 2 – Window
Description: Window Putty
Asbestos: **Chrysotile 1%**

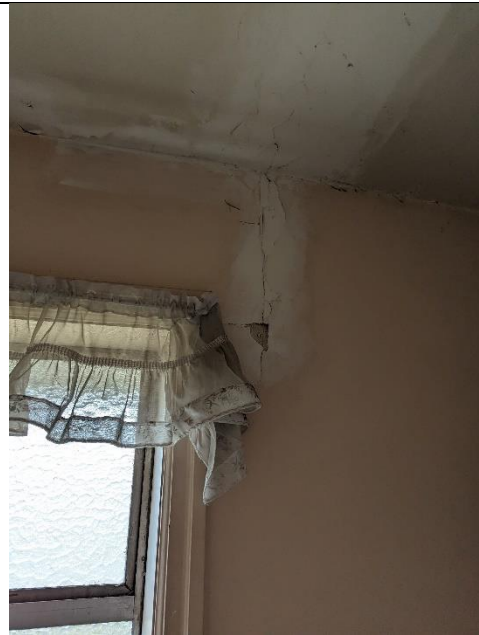
Sample: 50288 – 24
Location: Bathroom 2 – Wall
Description: Patching Compound
Asbestos: None detected

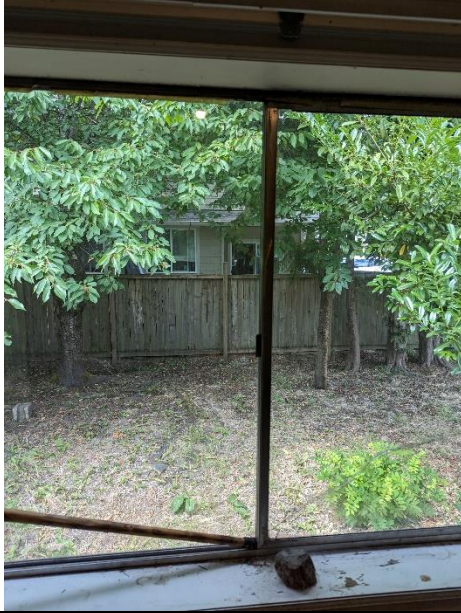
Sample: 50288 – 25
Location: Bedroom 4 – Window
Description: Window Putty
Asbestos: **Chrysotile 1%**

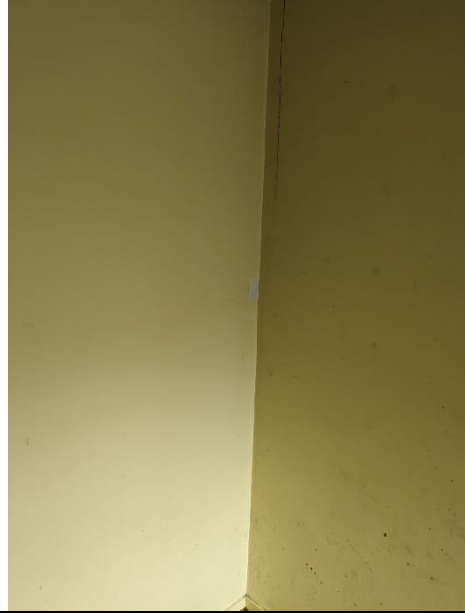
Sample: 50288 – 26
Location: Bedroom 3 – Wall
Description: Drywall Joint Compound
Asbestos: None detected

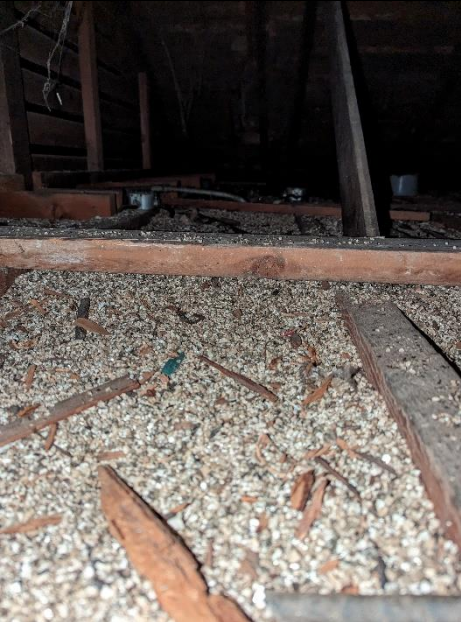
At the time of the investigation, it was observed that asbestos containing vermiculite from throughout the attic had fallen through cracks in the ceiling onto underlying surfaces within the house. As such, any entry into the building should be completed, at a minimum, with moderate risk work procedures, including the use of a HEPA-filtered face mask and a Tyvek suit, with all efforts to not to disturb the asbestos contamination.

A visual inspection of accessible areas within the attic space was conducted and vermiculite insulation was observed. This material may also exist in areas not inspected beneath insulation or within false ceilings, it may also exist within wall cavities and around chimneys. If discovered the material should be assumed to contain asbestos.

Sample: 50288 – 27
Location: Attic
Description: Vermiculite
Asbestos: **Tremolite 1%**

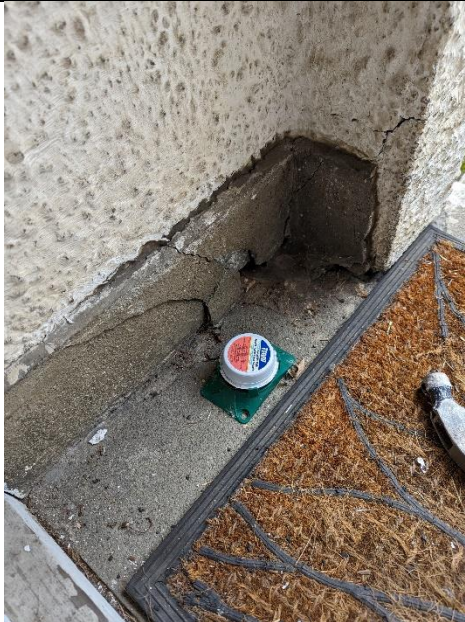
Sample: 50288 – 28
Location: Exterior – Near Entry – Base
Description: Cement Board
Asbestos: None detected

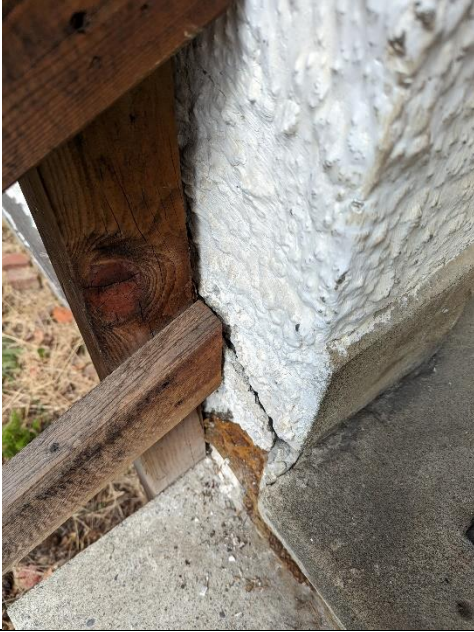
Sample: 50288 – 29
Location: Exterior – South
Description: Stucco
Asbestos: None detected

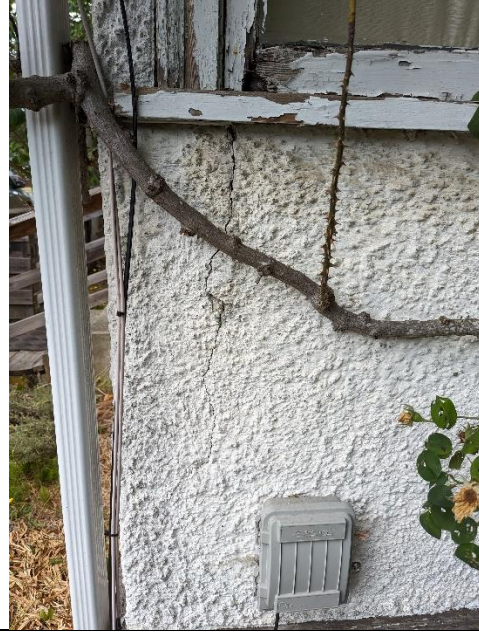
Sample: 50288 – 30
Location: Exterior – Southeast
Description: Stucco
Asbestos: None detected

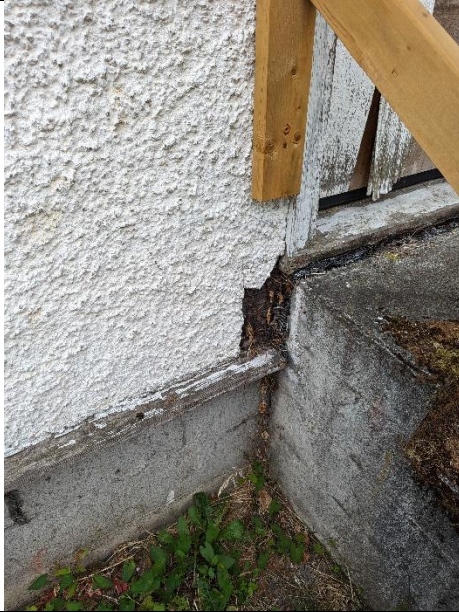
Sample: 50288 – 31
Location: Exterior – North
Description: Stucco
Asbestos: None detected

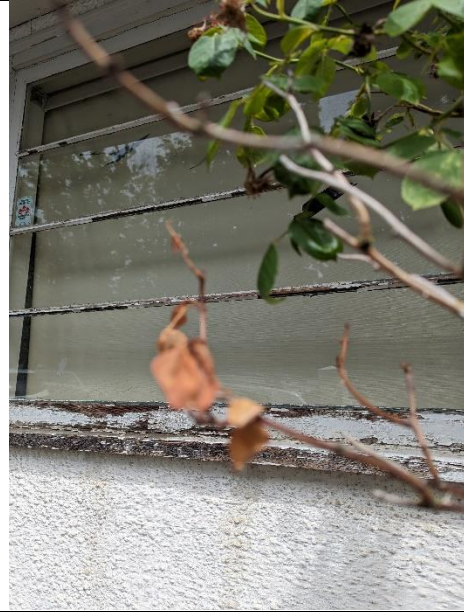
Sample: 50288 – 32
Location: Exterior – Window – South
Description: Window Putty
Asbestos: None detected

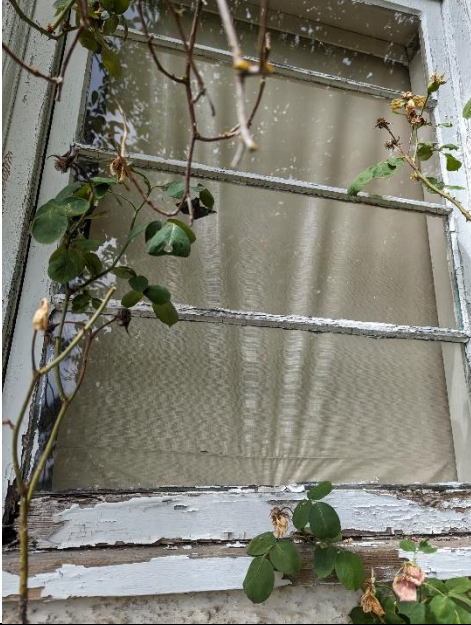
Sample: 50288 – 33
 Location: Exterior – Window – Southeast
 Description: Window Putty
 Asbestos: None detected

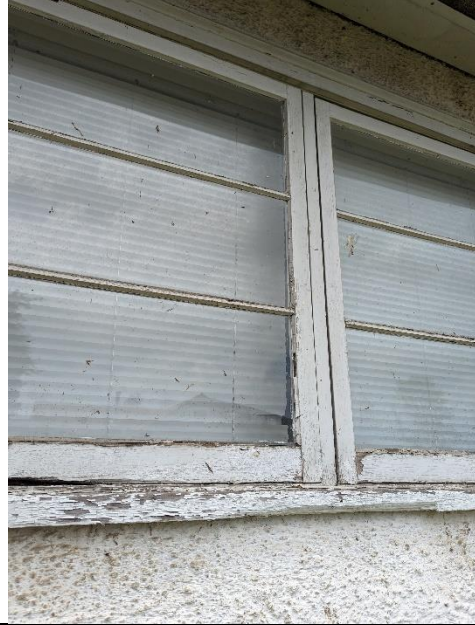
Sample: 50288 – 34
 Location: Exterior – Window – East
 Description: Window Putty
 Asbestos: **Chrysotile 6%**

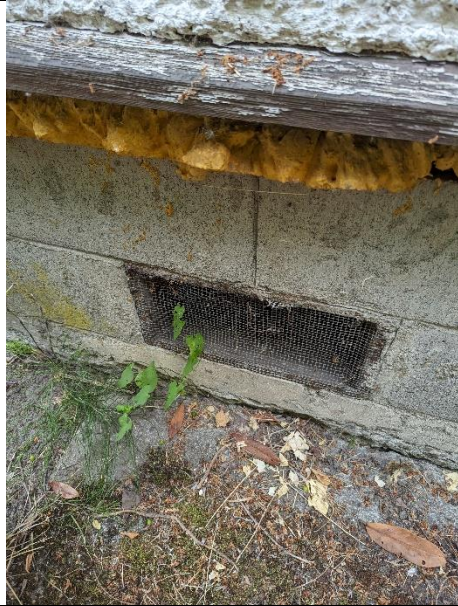
Sample: 50288 – 35
 Location: Exterior – Foundation
 Description: Brick Mortar
 Asbestos: None detected

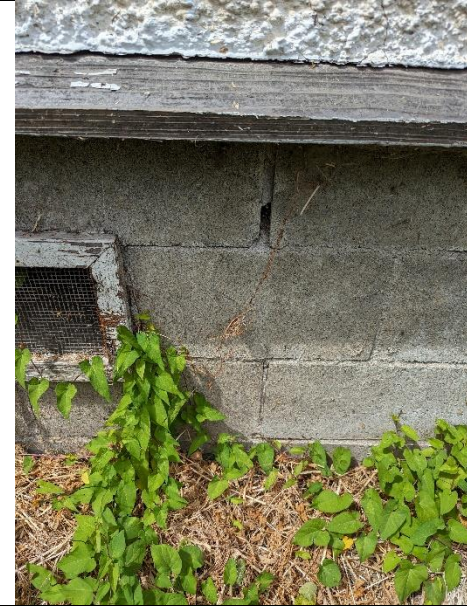
Sample: 50288 – 36
 Location: Exterior – Foundation
 Description: Brick Mortar
 Asbestos: None detected

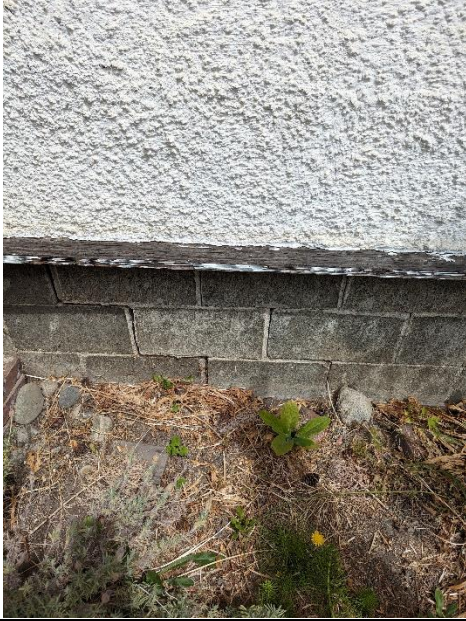
Sample: 50288 – 37
Location: Exterior – Foundation
Description: Brick Mortar
Asbestos: None detected

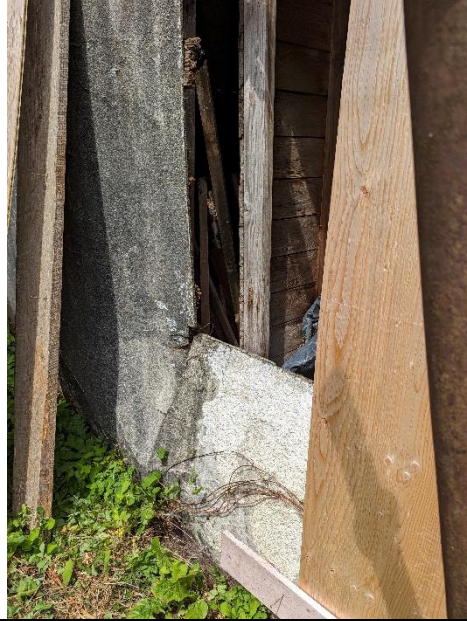
Sample: 50288 – 38
Location: Garage – Exterior
Description: Stucco
Asbestos: None detected

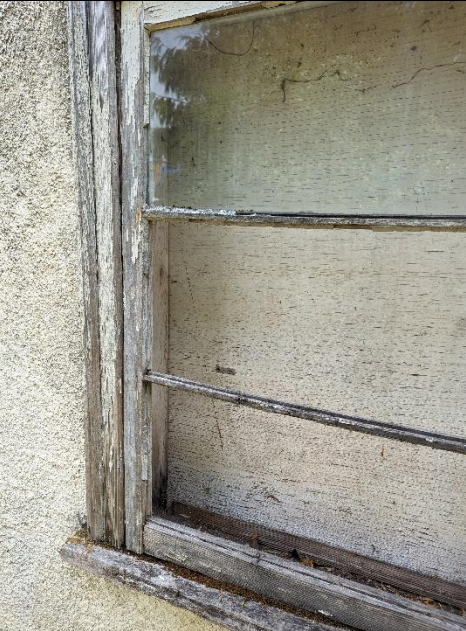
Sample: 50288 – 39
Location: Garage – Window
Description: Window Putty
Asbestos: None detected

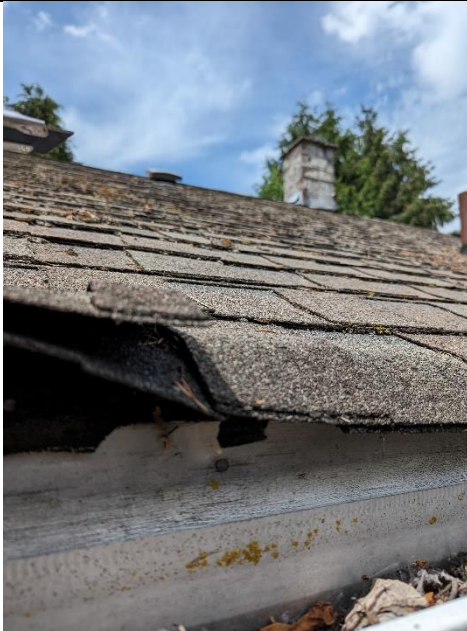
Sample: 50288 – 40
Location: Rooftop
Description: Tar Shingle/Roof Felt
Asbestos: None detected

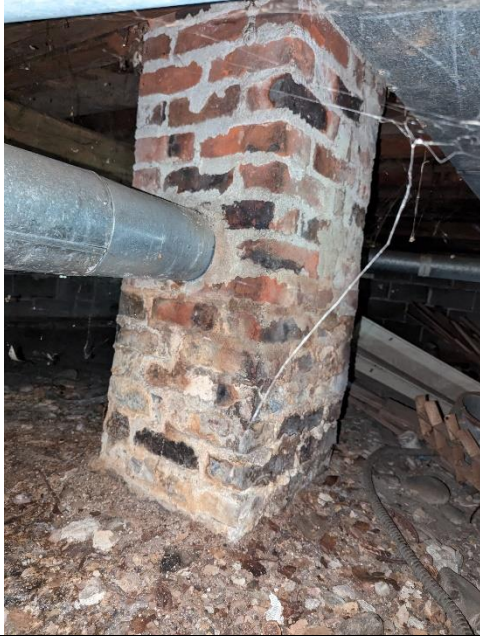
Sample: 50288 – 41
Location: Crawlspace – Chimney
Description: Brick Mortar
Asbestos: None detected

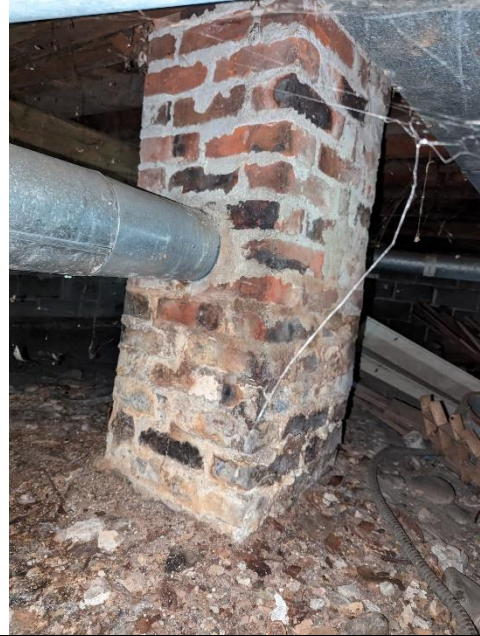
Sample: 50288 – 42
Location: Crawlspace – Chimney
Description: Brick Mortar
Asbestos: None detected

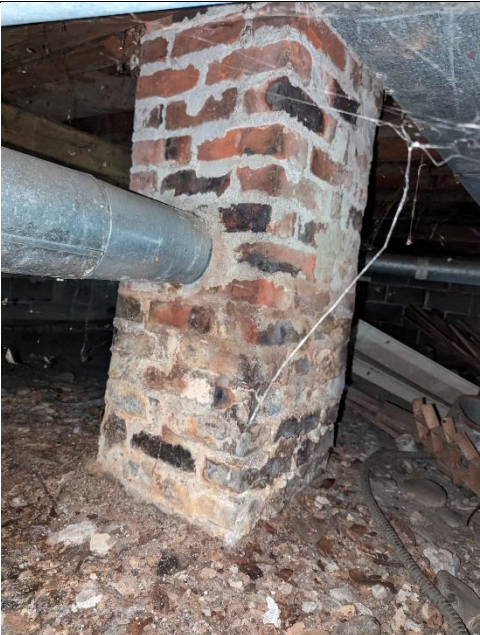
Sample: 50288 – 43
Location: Crawlspace – Chimney
Description: Brick Mortar
Asbestos: None detected

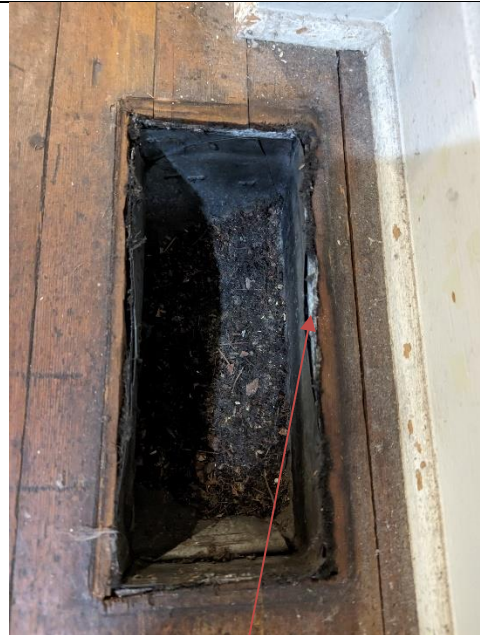
Sample: n/a
Location: Dining Room – Heating Vent
Description: Typical View of Asbestos
Containing Fibreboard
Asbestos: Typically, 60% Chrysotile

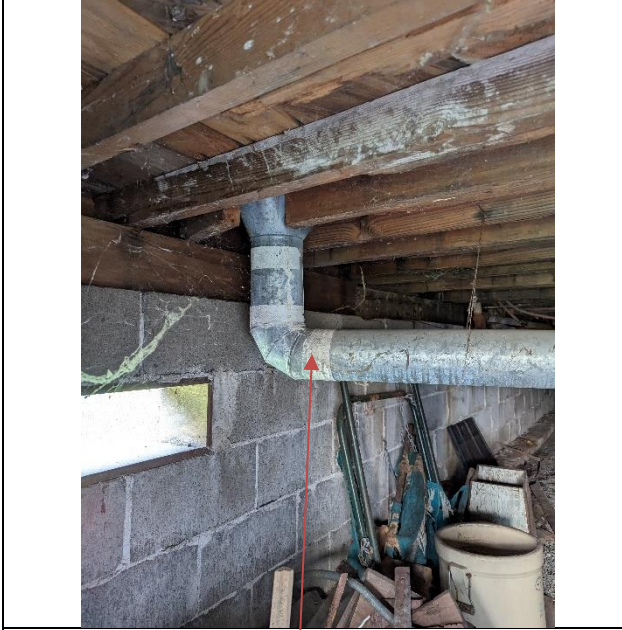
Sample: n/a
Location: Crawlspace – Heat Ducts
Description: Typical View of Asbestos
Containing Duct Tape
Asbestos: Typically, 60% Chrysotile
