**Pre-Demolition
Hazardous Materials Investigation**

177 Third Street, Duncan, BC

Island EHS Project # 50288

July 2023

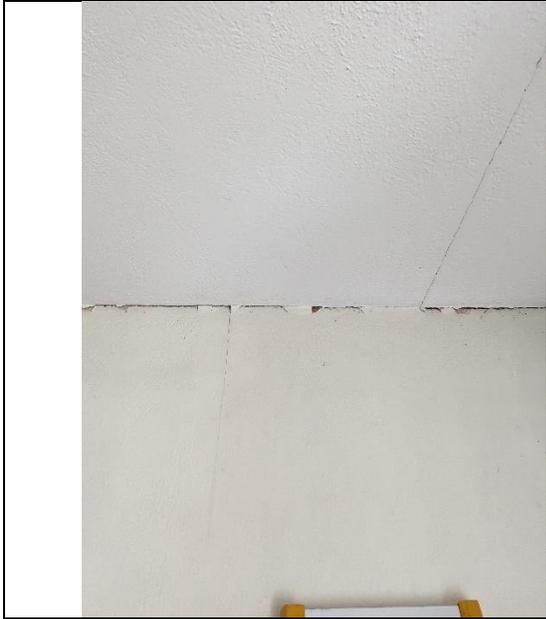
Sample: 50288 – 1
Location: Living Room – Ceiling
Description: Drywall Joint
Compound/Textured Coating
Asbestos: **Chrysotile 1%**

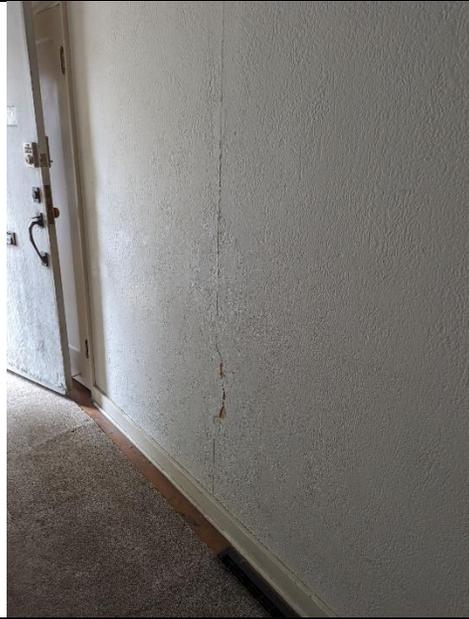
Sample: 50288 – 2
Location: Living Room – Wall
Description: Drywall Joint
Compound/Textured Coating
Asbestos: **Chrysotile 1%**

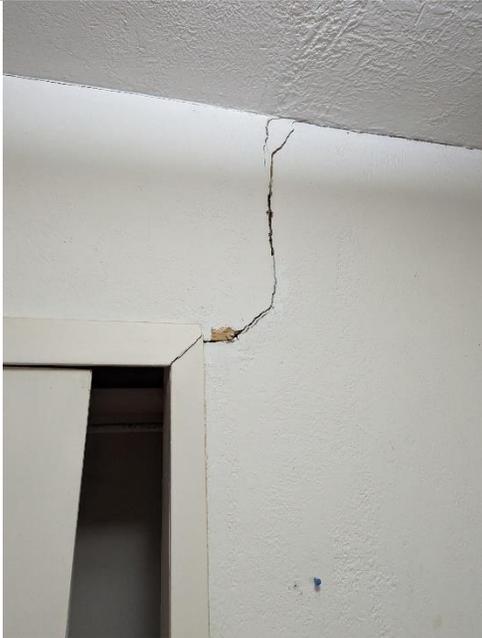
Sample: 50288 – 3
Location: Bedroom 1 – Wall
Description: Drywall Joint
Compound/Textured Coating
Asbestos: **Chrysotile 1%**

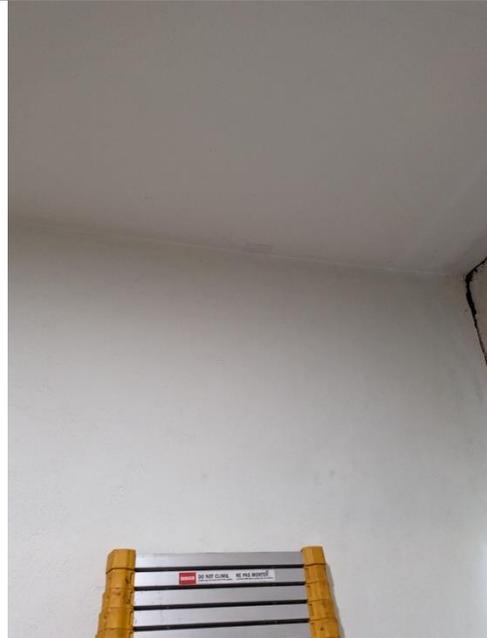
Sample: 50288 – 4
Location: Dining Room – Ceiling
Description: Drywall Joint
Compound/Textured Coating
Asbestos: **Chrysotile 1%**

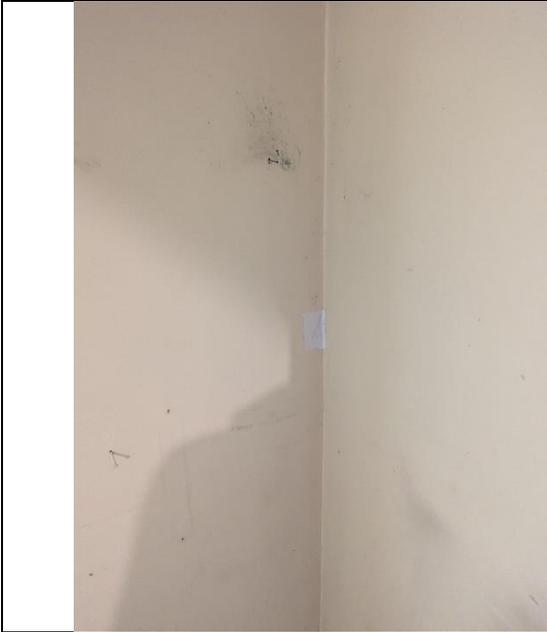
Sample: 50288 – 13
Location: Hallway
Description: Drywall Joint Compound
Asbestos: **Chrysotile 1%**

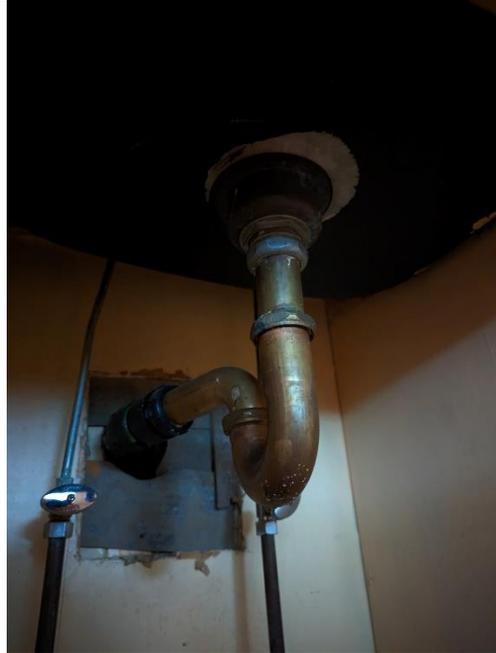
Sample: 50288 – 22
Location: Kitchen 2 – Sink
Description: Mastic (Black)
Asbestos: **Chrysotile 4%**

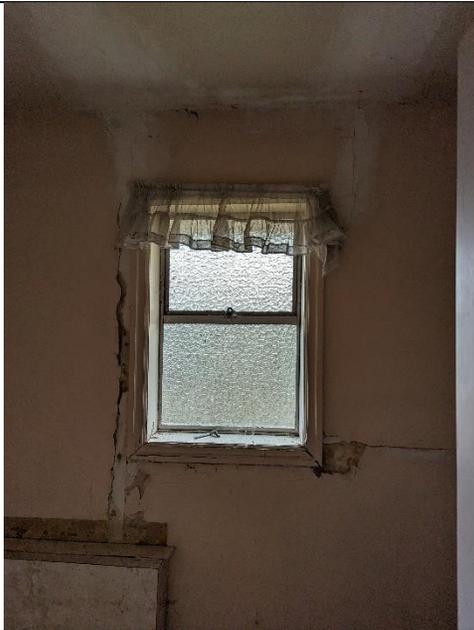
Sample: 50288 – 23
Location: Bathroom 2 – Window
Description: Window Putty
Asbestos: **Chrysotile 1%**

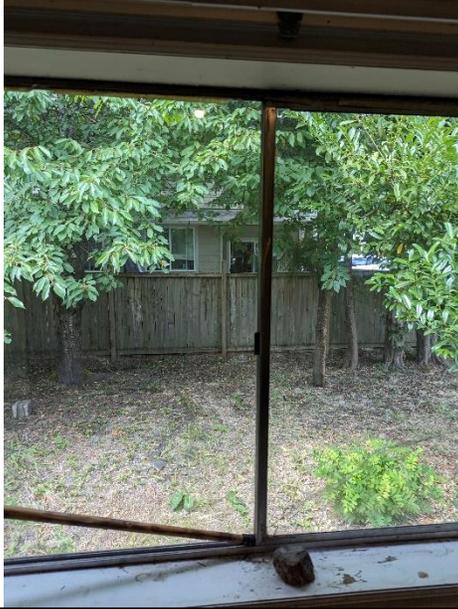
Sample: 50288 – 25
Location: Bedroom 4 – Window
Description: Window Putty
Asbestos: **Chrysotile 1%**

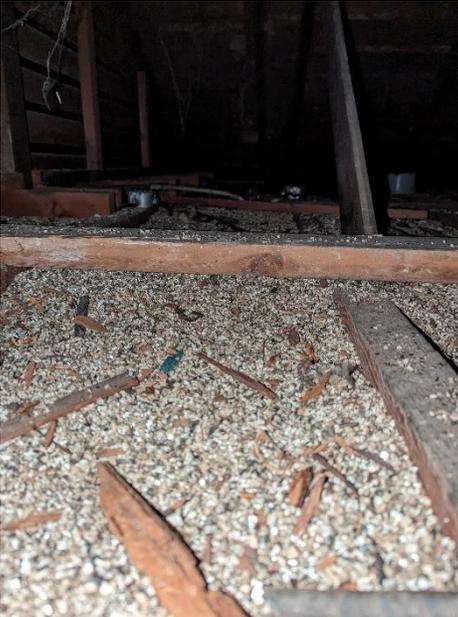
At the time of the investigation, it was observed that asbestos containing vermiculite from throughout the attic had fallen through cracks in the ceiling onto underlying surfaces within the house. As such, any entry into the building should be completed, at a minimum, with moderate risk work procedures, including the use of a HEPA-filtered face mask and a Tyvek suit, with all efforts to not to disturb the asbestos contamination.

A visual inspection of accessible areas within the attic space was conducted and vermiculite insulation was observed. This material may also exist in areas not inspected beneath insulation or within false ceilings, it may also exist within wall cavities and around chimneys. If discovered the material should be assumed to contain asbestos.

Sample: 50288 – 27
Location: Attic
Description: Vermiculite
Asbestos: **Tremolite 1%**

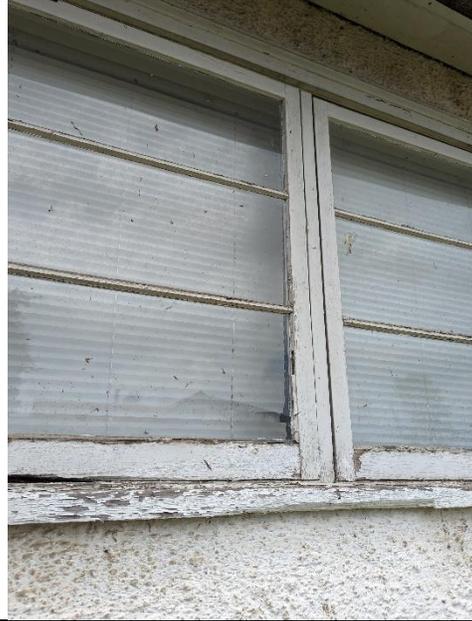
Sample: 50288 – 34
Location: Exterior – Window – East
Description: Window Putty
Asbestos: **Chrysotile 6%**

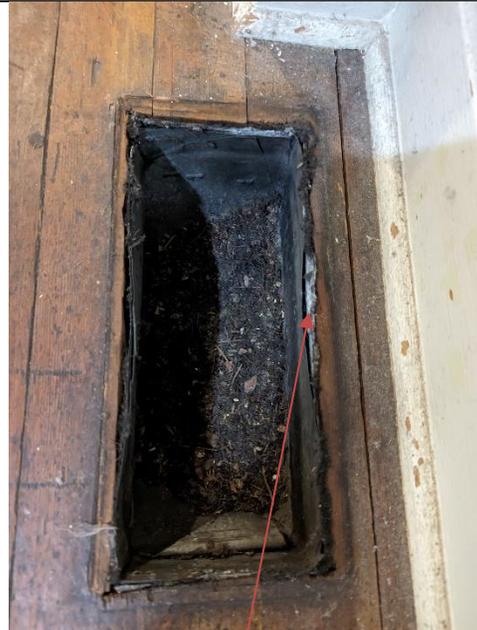
Sample: n/a
 Location: Dining Room – Heating Vent
 Description: Typical View of Asbestos
 Containing Fibreboard
 Asbestos: Typically, 60% Chrysotile

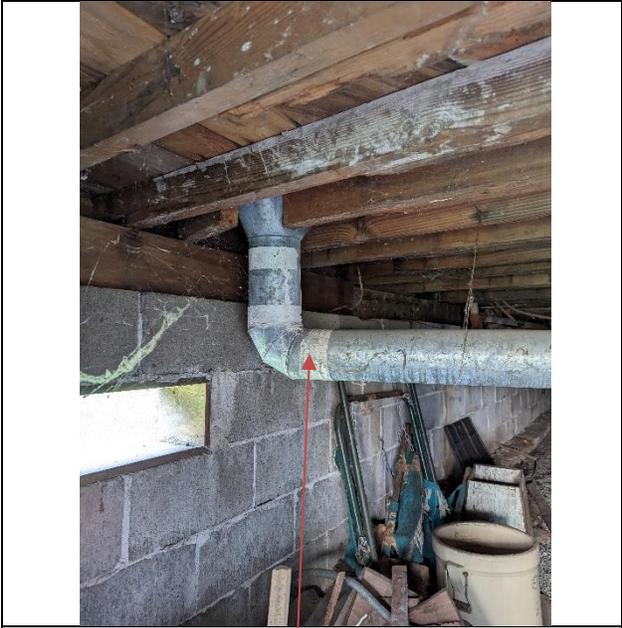
Sample: n/a
Location: Crawlspace – Heat Ducts
Description: Typical View of Asbestos
Containing Duct Tape
Asbestos: Typically, 60% Chrysotile

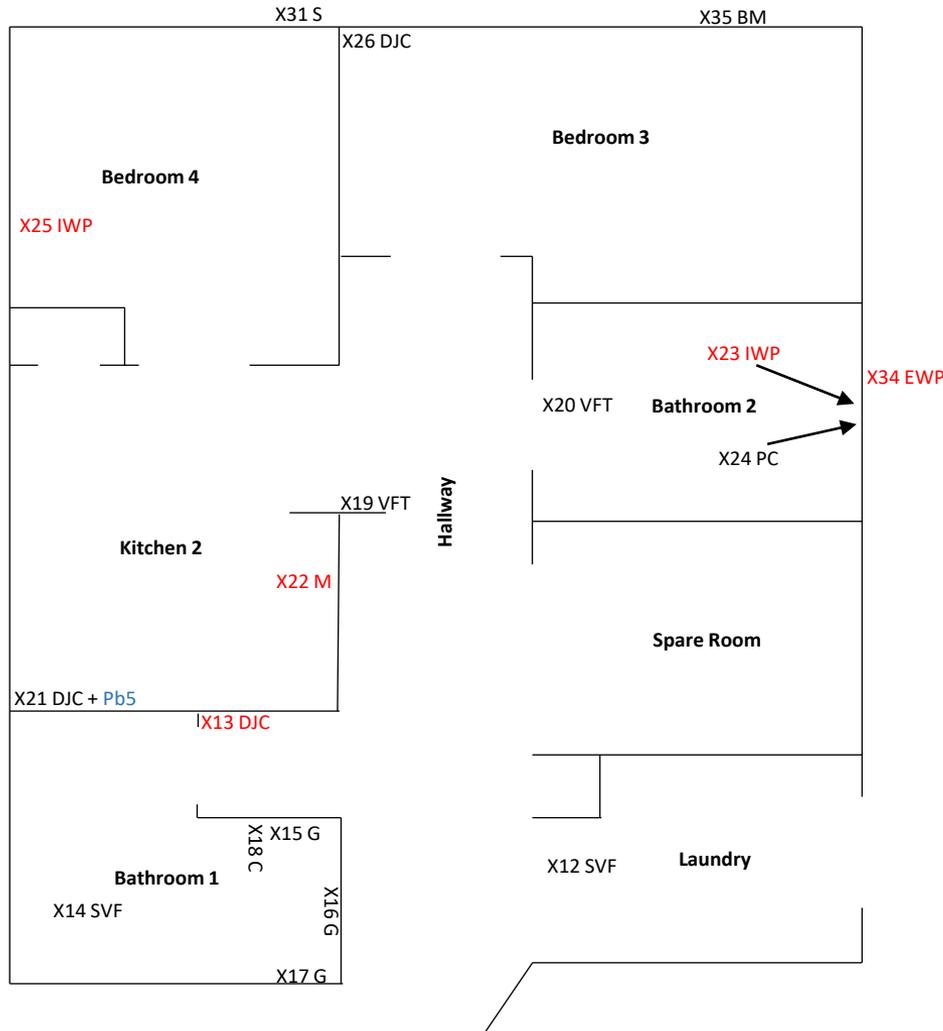
Sample Locations - North

X27 V = Attic Space
 X40 TS/RF = Rooftop
 X41 BM, X42 BM, X43 BM = Crawlspace

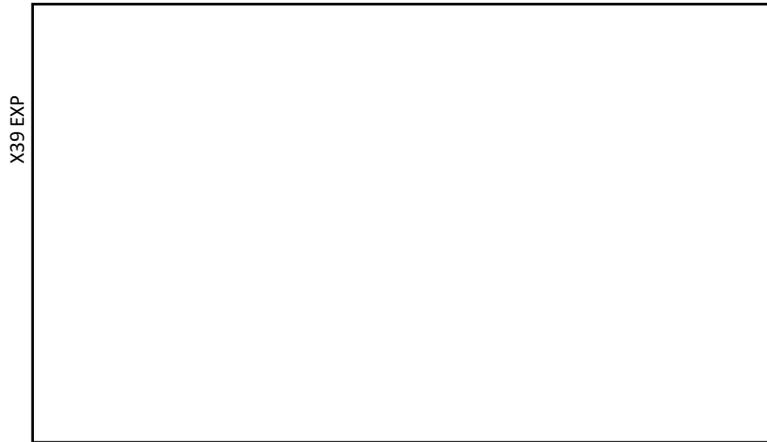
Sample Locations - Garage

X38 S
