SIE Consultants

Stage 1 Preliminary Site Investigation

177 Third Street, Duncan, BC

26 July 2023
File No.: V123-46

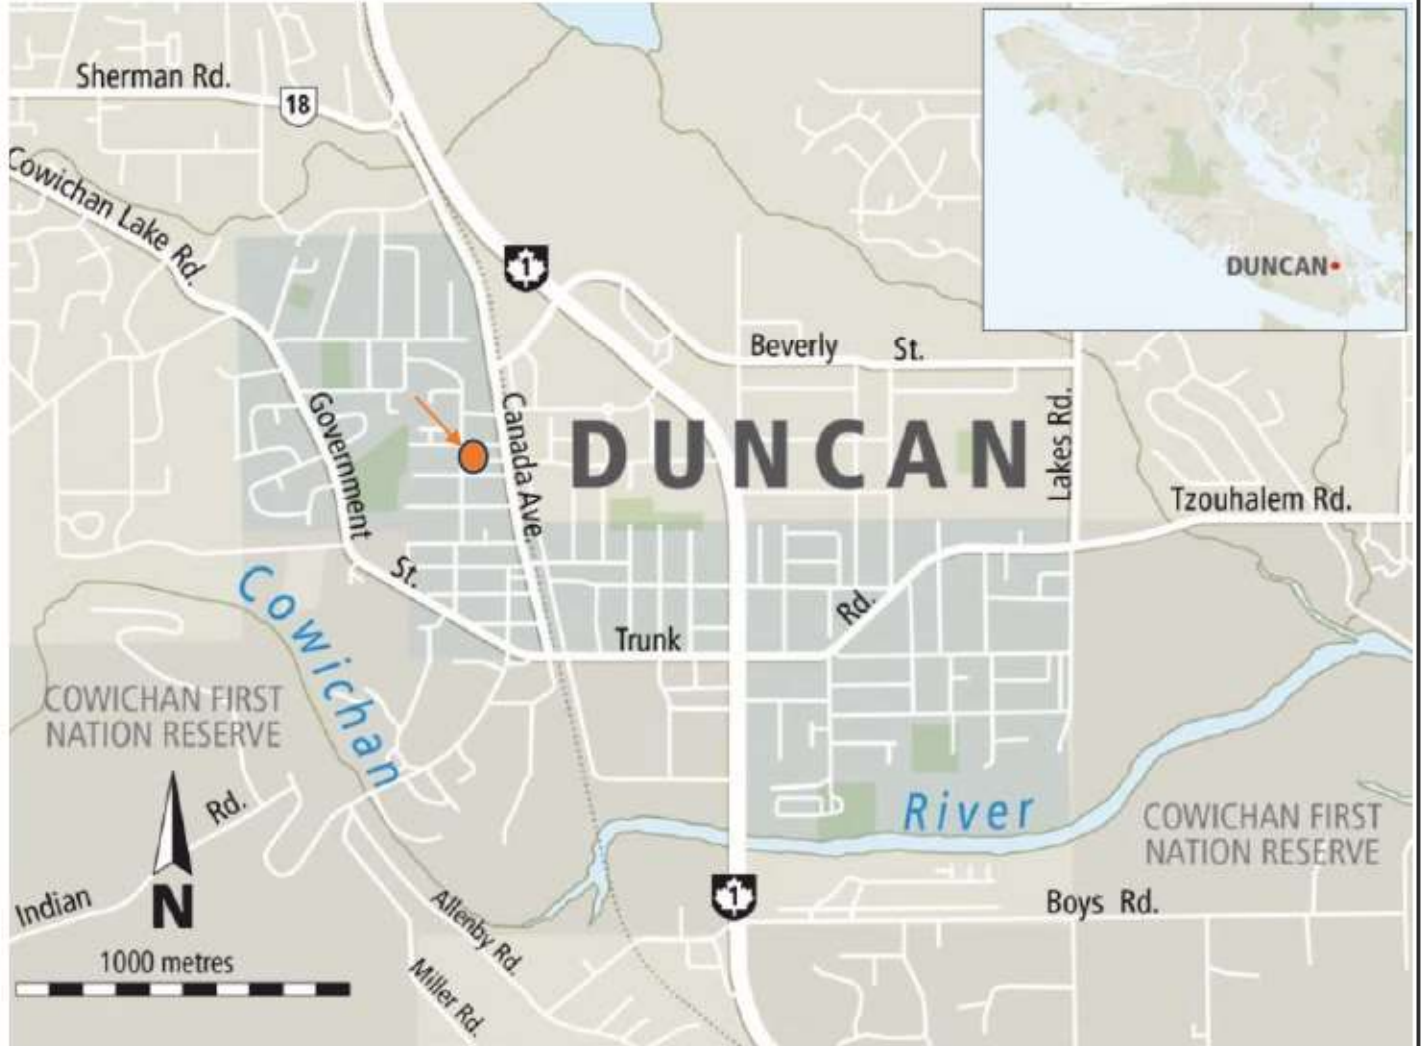
PROJECT: STAGE I PRELIMINARY SITE INVESTIGATION 177 THIRD STREET, DUNCAN, BRITISH COLUMBIA			
	TITLE: SITE LOCATION			
	CLIENT: CITY OF DUNCAN			
FIGURE NO.: 1	DATE: 18 JULY 2023	FILE NO.: VI23-46	SCALE: N/A	COMPLETED BY: EG

The property is located along the north side of Third Street approximately 95 meters west of Canada Avenue in Duncan, BC. (See Site Plan: Figure 1, Appendix 1). As required by the ENV, a summary of site information is provided in Table 1 below.

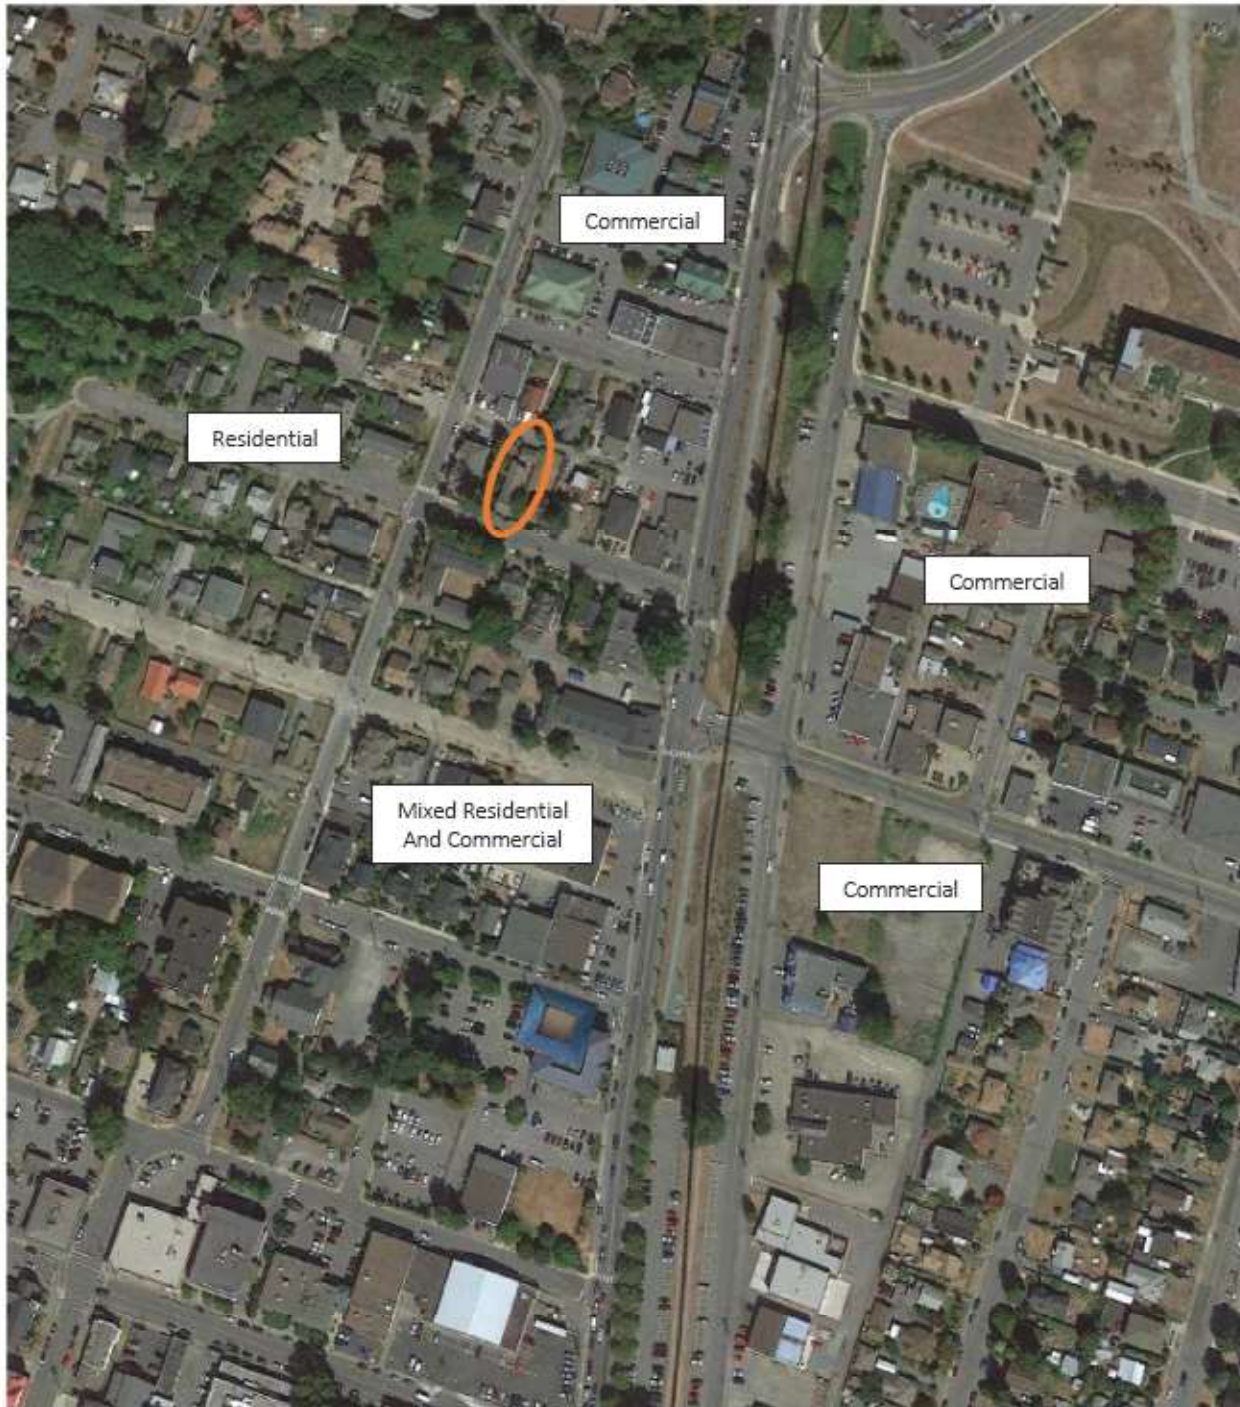
PROJECT: STAGE 1 PRELIMINARY SITE INVESTIGATION 177 THIRD STREET, DUNCAN, BC			
	TITLE: SURROUNDING LAND USE PLAN			
	CLIENT: CITY OF DUNCAN			
FIGURE NO.: 2	DATE: 18 JULY 2023	FILE NO.: VI23-46	SCALE: N/A	COMPLETED BY: EG

Underground services in the area include municipal water, storm and sanitary sewer, and natural gas. Aboveground services include telephone, cable, and hydro. The immediate surrounding properties are mainly for commercial and residential uses. A surrounding land use plan is attached in Appendix 1 as Figure 2.

A Surrounding Land Use Plan showing the current land use in the vicinity of the Site is provided in Figure 2, Appendix I. A summary of the surrounding area land uses is noted in Table 5.

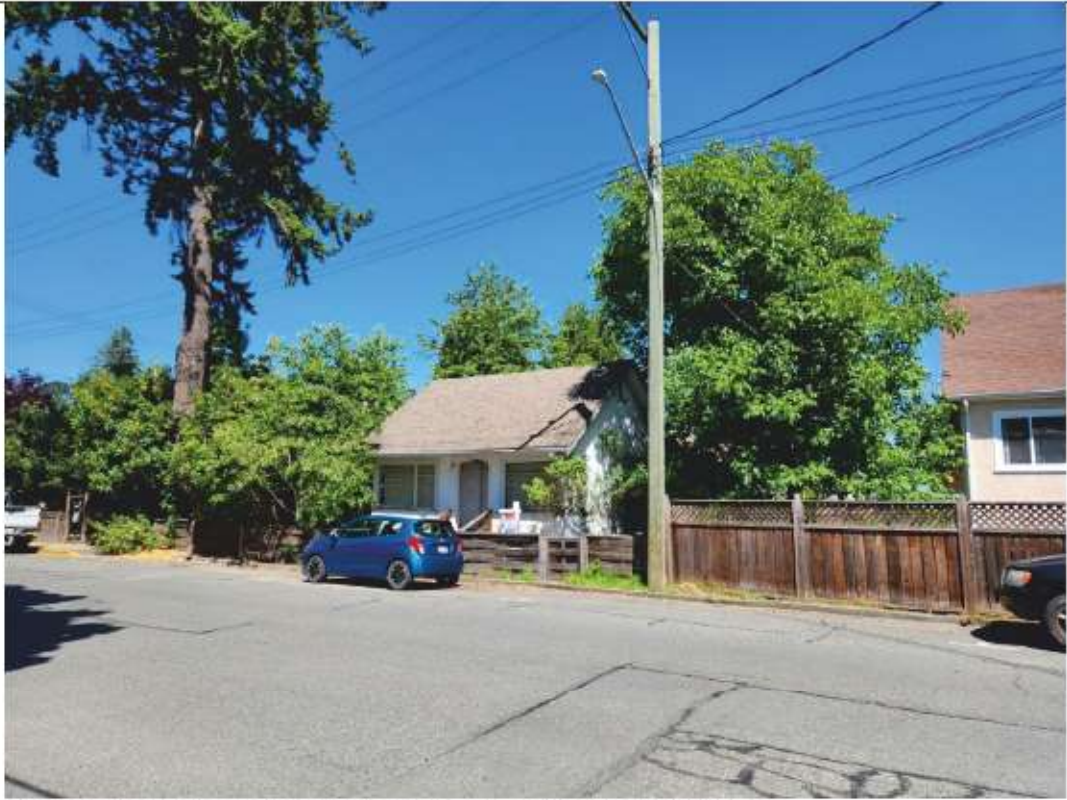
Photograph 1 Photo showing the Site from the south side of Third Street.

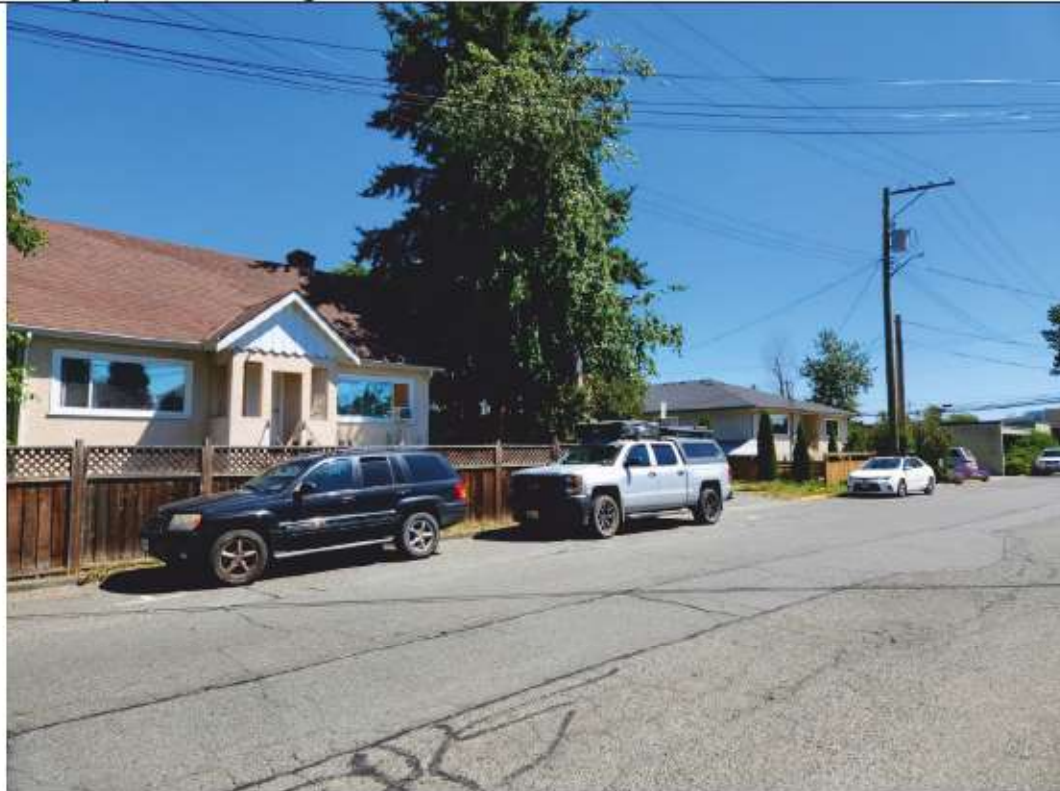
Photograph 2 Photo showing the residential housing east of the Site from the south side of Third Street.

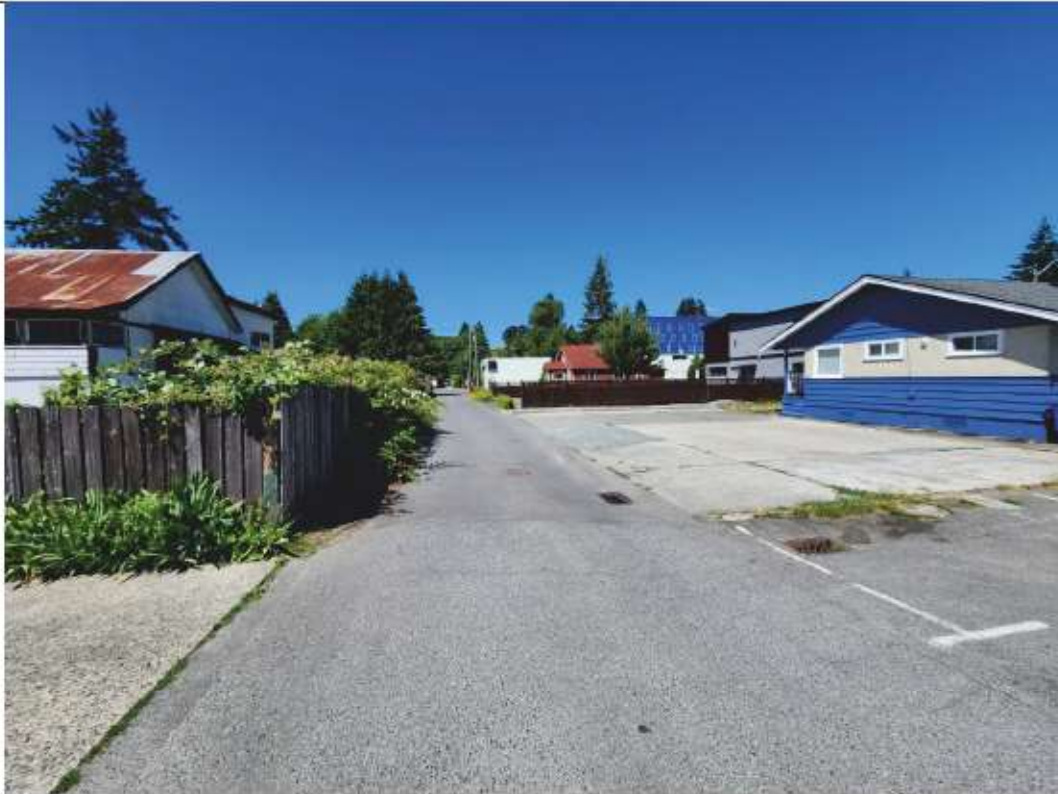
Photograph 3 Photo showing the alleyway adjacent and north of the Site. Photo taken from the east looking west.

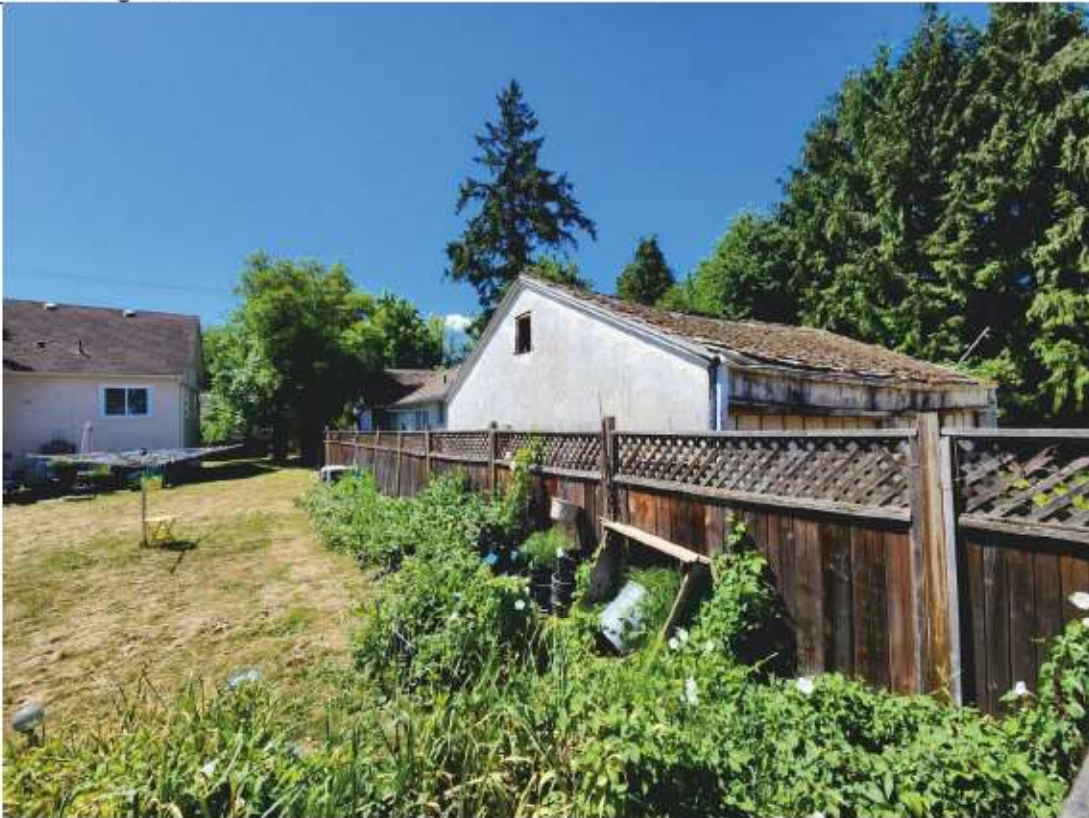
Photograph 4 Photo showing the east property boundary of the Site from the rear alleyway.

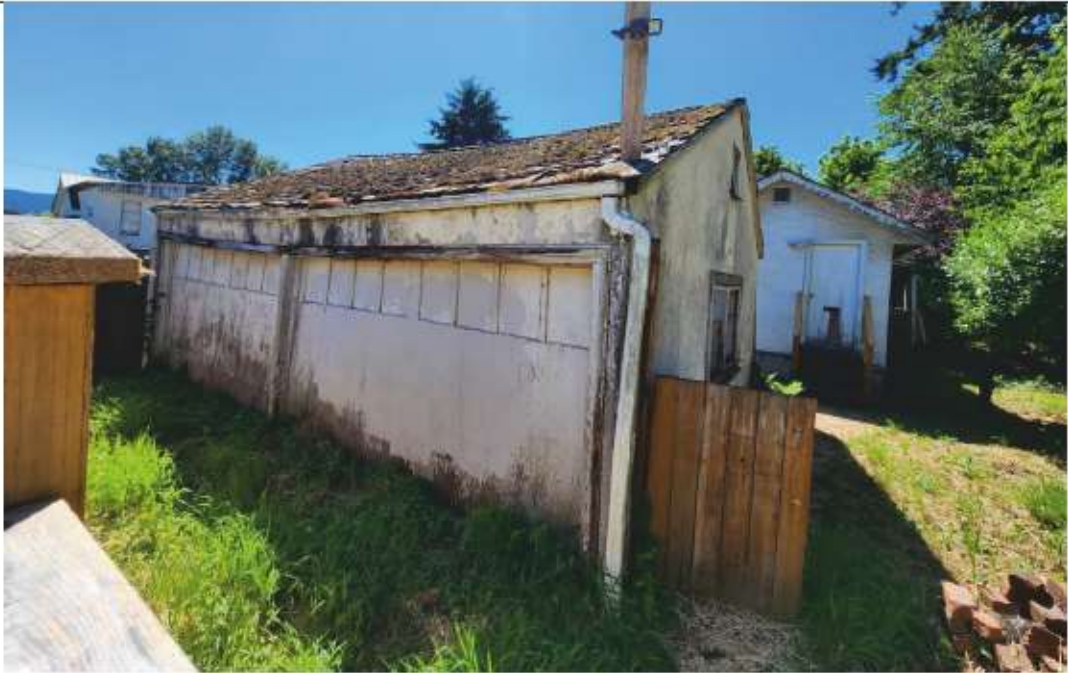
Photograph 5 Photo showing the two-car garage located at the rear of the property. Photo taken from the north property boundary looking south.

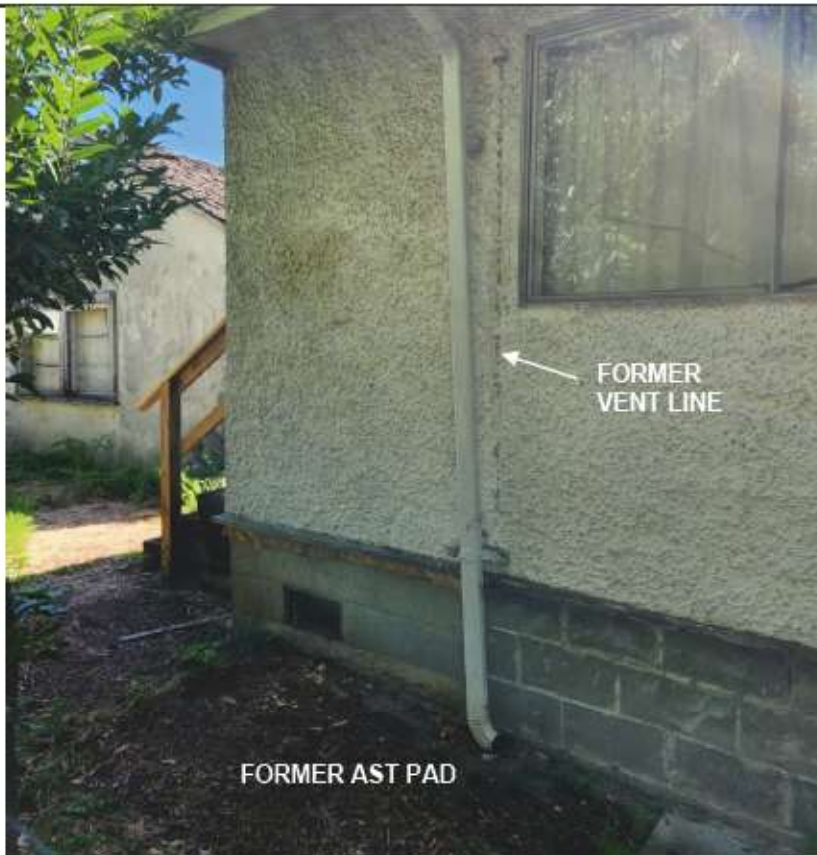
Photograph 6 Photo showing former AST pad and vent line locations at northwest corner of house.

Signs of heating fuel aboveground storage tanks (ASTs) were noted at the subject site. Specifically, a concrete pad adjacent to the west side of the house was observed with capped fuel lines identified at approximately 1m above ground. In addition, a second concrete pad was observed on the west side of the house with a vent pipe anchor noted on the siding. The City of Duncan provided records of a 1964 permit to install two (2) fuel-oil burning furnaces and an aboveground 250-gallon storage tank, along with a building permit to convert the dwelling to a duplex. Additional records provided from 1956 indicated that oil-burning equipment was used as a heating source for the dwelling. It is unknown if an underground heating oil storage tank was historically used on the Site. Fuel storage tanks are considered an APEC. If suspect impacted soil from potential historical spills/leaks is encountered during future development of the site, SIE should be contacted to assess the quality of the soil prior to any off-site disposal.

Based on the findings of this Stage 1 PSI, SIE considers the subject site classed as low environmental risk. The only APEC is the former aboveground heating oil tanks; impacts related to ASTs are considered relatively low. During any future site development, SIE recommends that a soil quality assessment be completed (for offsite disposal purposes) prior to the excavation and removal of soils from the Site, including a soil assessment in the two AST pads. SIE also recommends that the Site be scanned for historical underground heating oil tanks.

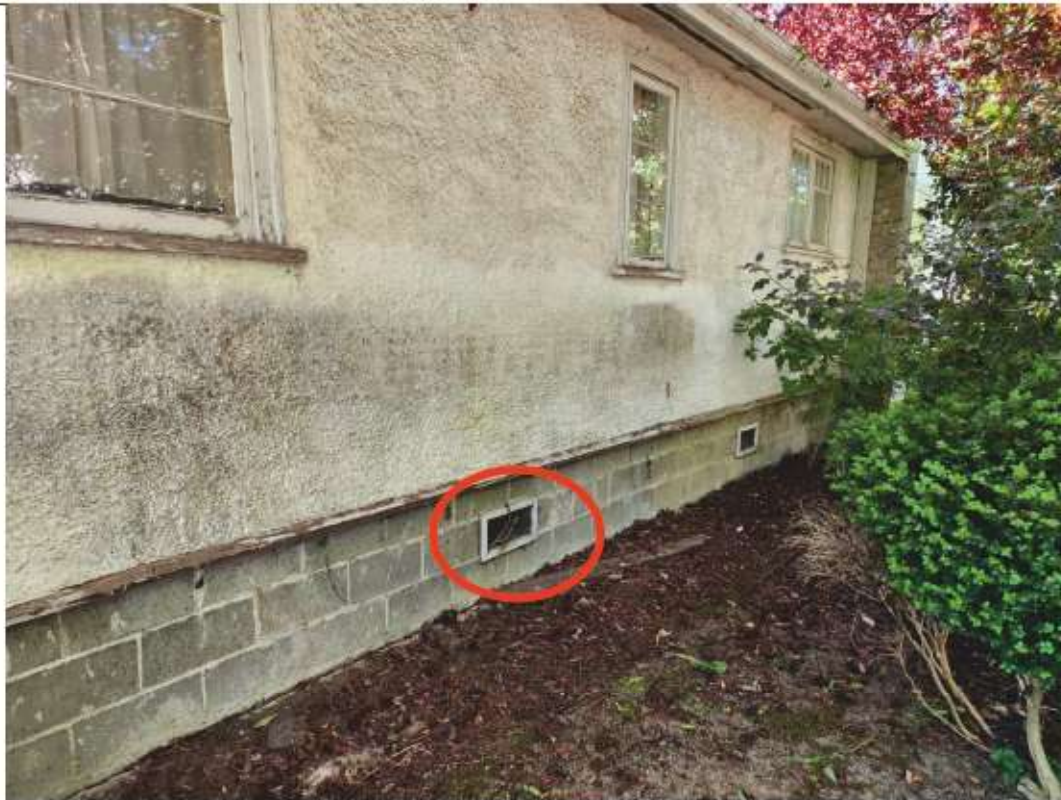
Photograph 7 Photo showing the heating oil AST supply lines, located on the west side of the house.
