LOWER COWICHAN / KOKSILAH RIVER INTEGRATED FLOOD MANAGEMENT PLAN

FINAL REPORT

SEPTEMBER 2009

nhc northwest
hydraulic
consultants

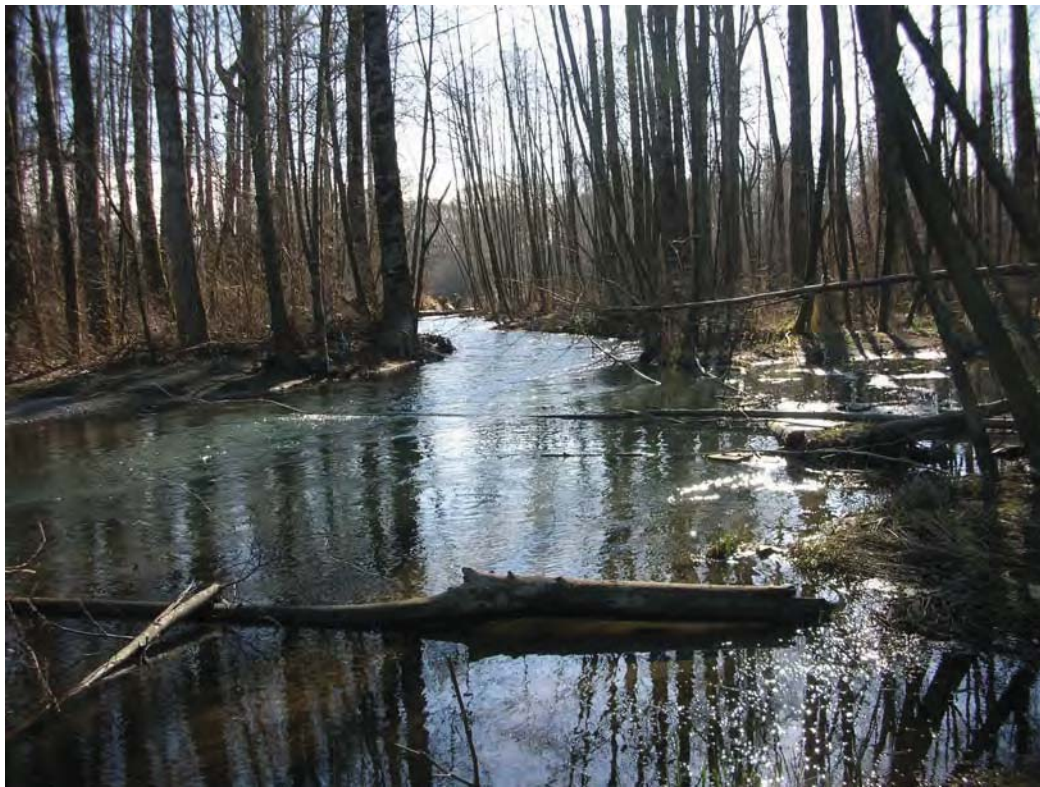
Photo 2.5: Overbank flooding at right bank near km 5.1 and flooding into Fish Gut alley at discharge of 33 m³/s. (February 17 09).

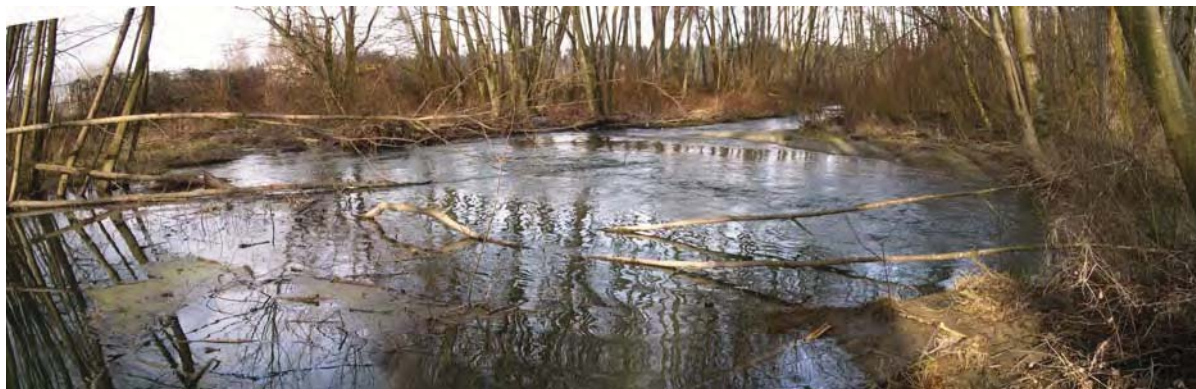
Proposed upgrades to the JUB Sewage Lagoon dike will increase freeboard around the overall 1.1 km perimeter giving rise to an estimated 5 m horizontal displacement beyond the existing structure. As an added measure of flood protection 670 m x 5 m of rock armouring is proposed along the toe of the upgraded dike as shown in Figure 8.1. An estimated 6,700 m² of sensitive aquatic and riparian habitat associated with lower Fish Gut Alley channel will be altered (Photo 8.1).

Photo 8.1: Downstream view of lower Fish Gut Alley side-channel

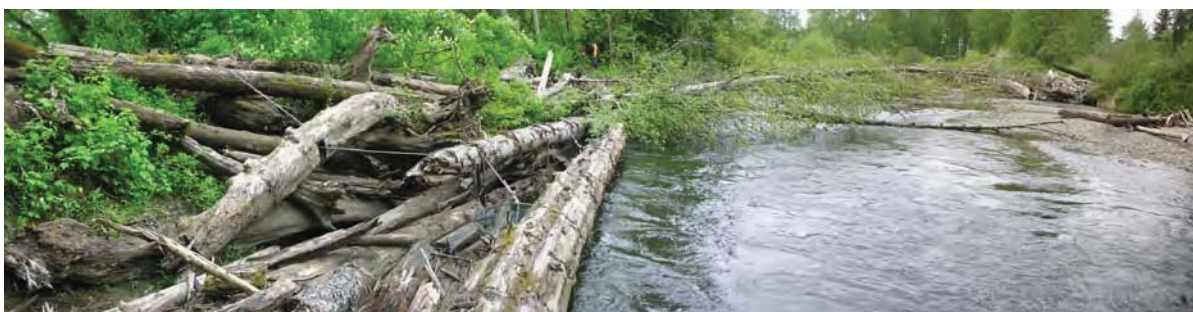
Photo 8.3 : Upstream view of log jam on Koksilah River at km 3+290

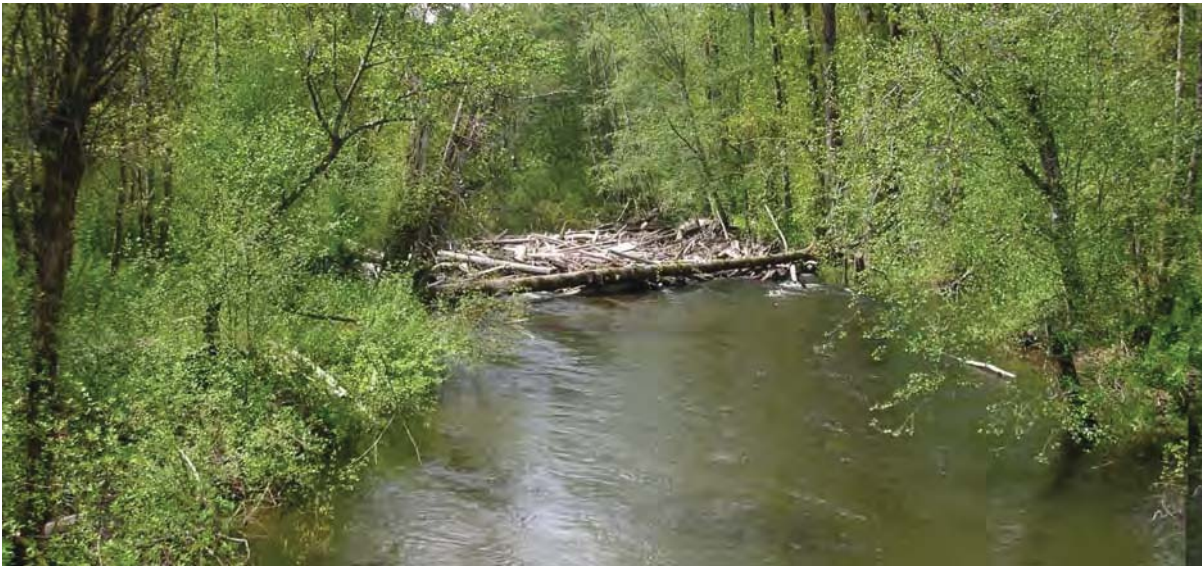
The goal of this strategy is to proactively remove or stabilize debris jams of concern before threats to infrastructure occur. A channel spanning debris jam located on Koksilah River at km 3+290 should be further assessed to determine flood risk to the Koksilah Dike, residential property and the E&N Railway crossing located downstream (Figure 8.8 and Photo 8.5).

Photo 8.5: Upstream view of log jam on Koksilah River at km 3+290

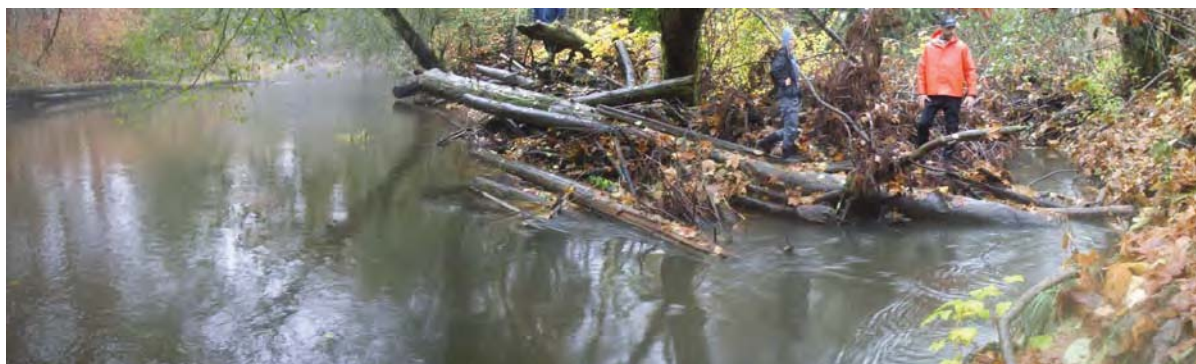
Photo 8.6: Downstream view of LWD jam partially obstructing side-channel intake at km 1+380 LB

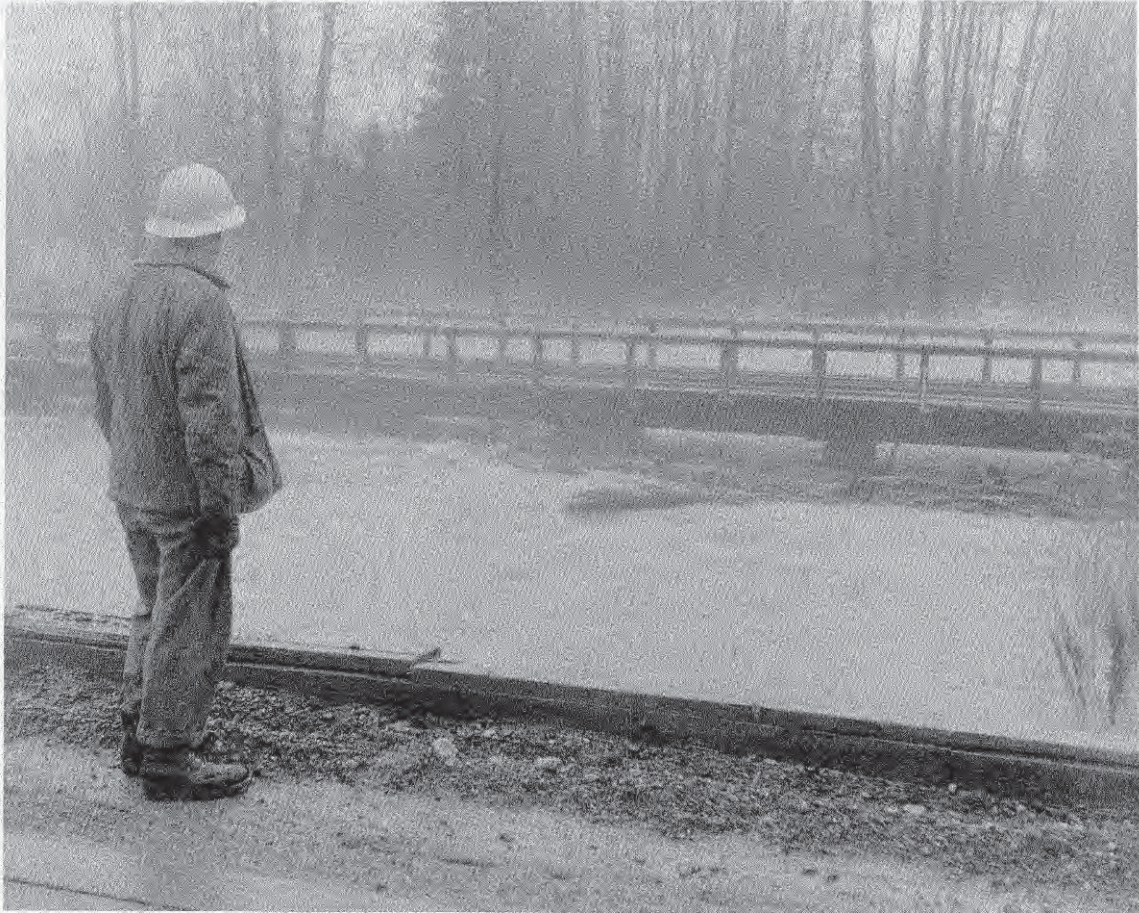
Log jam forming at upstream end of bridge.

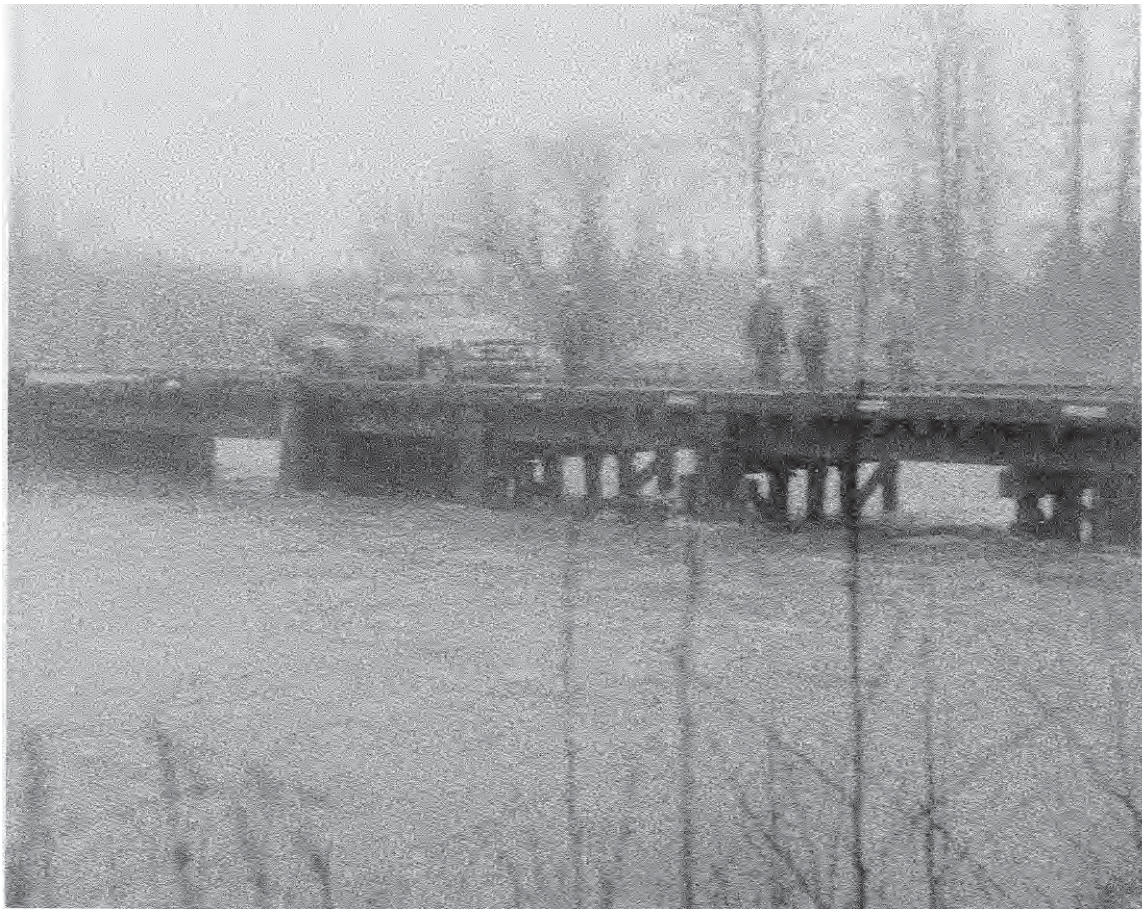
Log jam starting to form at upstream side of bridge.

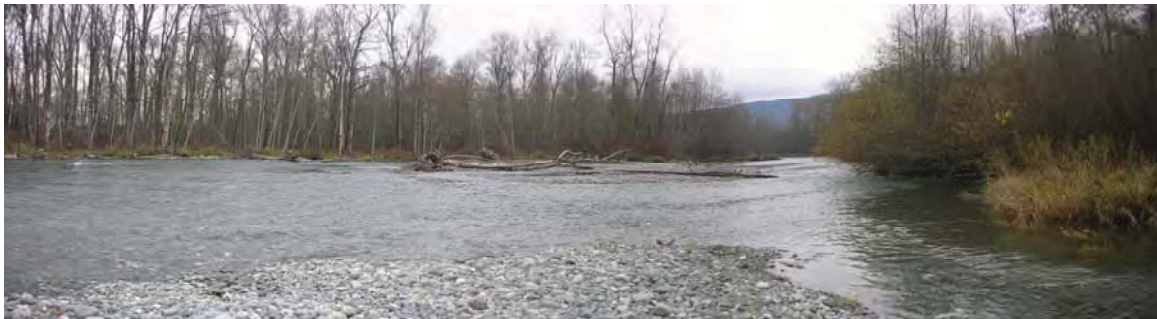
Photo A.6. Lateral view of the mainstem Cowichan River at km 5.1 illustrating high quality spawning habitat that continues to support chum and coho spawners. The mature and intact riparian habitat is dominated by Black Cottonwood and provides high quality wildlife habitat. This site is also a proposed gravel removal site as part of the flood maintenance program. Approximately 1800 m³ of gravel was removed in June 2007 as part of emergency works to the JUB outfall (Nov 2008).

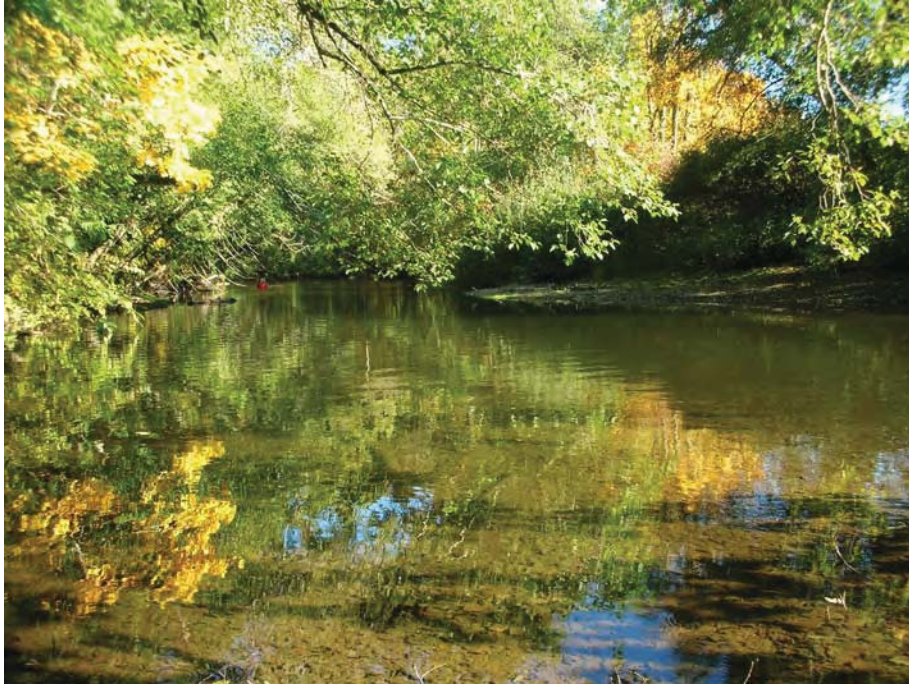
Photo B.15. Downstream view of the mainstem Koksilah illustrating shallow water conditions, with minimal instream or overhead cover for migrating spawners or juvenile salmonids (Oct 22 2008).

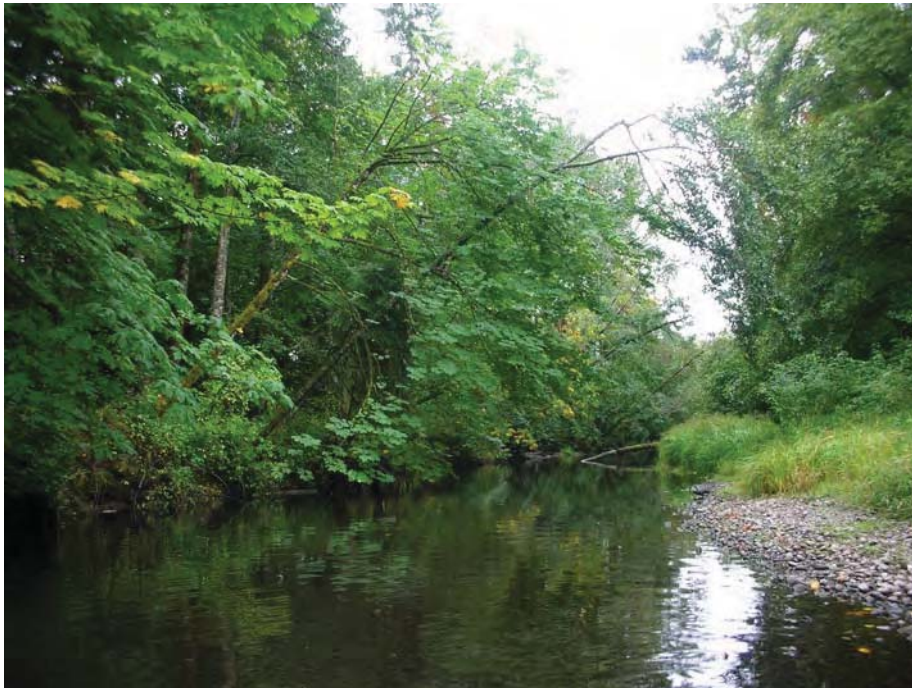
Photo B.16. Upstream view of the mainstem Koksilah where the right bank is actively eroding and immature riparian trees are collapsing into the channel (September 2009).
